Analytical Research of the Container Ships Cargo Area Fires in the Period From 2010 to 2020

Krmek, Ivica; Kos, Serđo; Brčić, David

Review / Pregledni rad

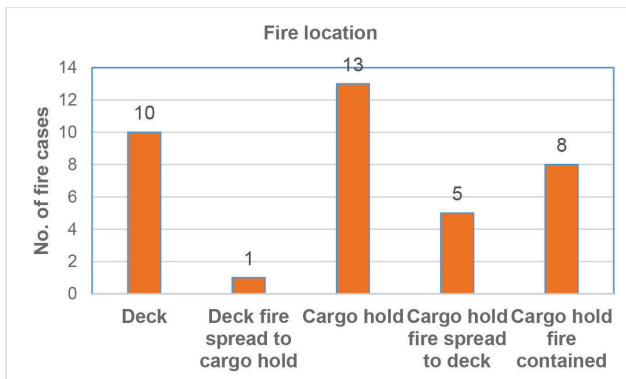
As can be seen in Figure 1, 10 fires broke out on the deck, while 13 in cargo holds. Five of the fires that started in cargo holds spread to the deck, while eight were contained in cargo holds and extinguished.

Figure 1 Fire locations in analysed cases
Slika 1. Lokacije požara u analiziranim slučajevima

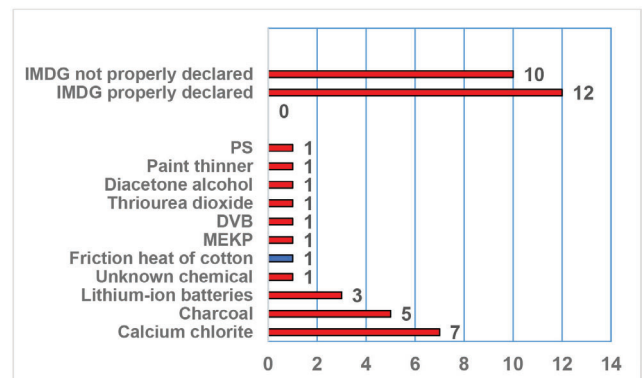
Figure 2 represents the causes of 23 analysed fires. It can be noted that the two most common causes of fires are various forms of calcium chlorite and charcoal. However, the consequences of fires caused by calcium chloride are much more severe due to this chemical's nature. Calcium hypochlorite $\text{Ca}(\text{ClO})_2$ [43] or calcium chlorite $\text{Ca}(\text{ClO}_2)_2$ [44] and its forms represent one of the most dangerous IMDG cargoes and were responsible for many container ship fires in the past. That is why the Cargo Incident Notification System (CINS) issued "Guidelines for the Carriage of Calcium Hypochlorite in Containers" in January 2018 [45]. The document describes this cargo's characteristics, the

IMDG classes, the potential risks associated with its transport, the selection of containers, storage, packaging, and inspection before loading the ship. This figure shows that 22 out of 23 fires were caused by IMDG cargo. Only one fire (highlighted blue) was caused by the non-IMDG cargo, i.e. the self-ignition of the cotton in the container as a result of the heat released due to the friction caused by the collapse of the container stack stow. Ten fires out of 22 were caused by the IMDG cargo which was either not declared as IMDG or was mis-declared. Given that the total number of fires analysed is 23, this means that 43% of fires were caused by undeclared or mis-declared IMDG cargo.

Figure 2 Causes of fire in analysed cases
Slika 2. Uzroci požara u analiziranim slučajevima

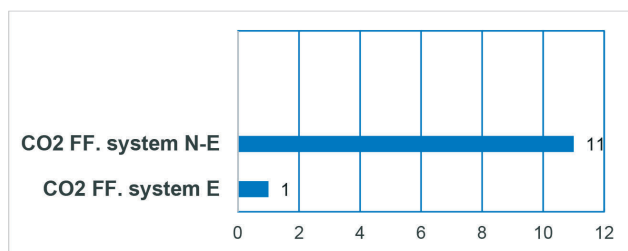
The evaluation of the fixed CO₂ fire extinguishing system and efficiency of the entire firefighting operations is based on the data obtained from the investigation reports related to the fire cases analysed in this paper. Cargo holds' fixed CO₂ fire extinguishing system efficiency is presented in Figure 3. As already mentioned, 13 fires broke out in cargo holds. In one case, the fire was extinguished very quickly, and there was no need to release a fixed CO₂ firefighting system. In 12 cases, the crew decided to release a CO₂ firefighting system. In only one case the CO₂ system proved to be effective, and the fire was extinguished, while in the other 11 cases it was partially or entirely inefficient. There are several main reasons for the inefficiency of the CO₂ system:

- limited efficiency for extinguishing deep-seated fires inside containers, especially for those types of cargo (e.g., lithium-ion batteries, cotton in bales) that smolder for a long time after the flame is extinguished and which re-ignite when the oxygen re-enters the scene of the fire;

- CO₂ extinguishes fire by reducing oxygen content as it is heavier than air, but it has a limited cooling effect. This poses a risk of fire re-ignition once oxygen is re-introduced to the cargo hold;

- if the container on fire is located on higher tiers close to the hatch covers, CO₂ won't have a fire extinguishing effect due to the constant inflow of fresh air;

- some IMDG cargoes are known as oxidizing materials (e.g., calcium hypochlorite), which release oxygen as a result of their instability and decomposition at elevated temperatures;

- limited gas tightness of the cargo holds due to the design and construction of the hatch covers. Namely, the covers of large container ships are of lift-away type, consisting of several panels for each cargo hold opening, arranged transversely, and separated by a longitudinal gap of less than 50 mm. The panels rest on bearing pads placed on top of the hatch coamings and do not have rubber packing which makes the cargo hold weather tight. The designed air gap between hatch covers and hatch coamings is 10 - 20 mm;

- if the fire spreads rapidly, there is a significant risk that some of the ventilation flaps and covers won't be accessible due to the smoke on deck;

- technical malfunctions of the CO₂ system due to poor maintenance, poor and improper installation of the system, and pipe leakage during system activation.

Figure 3 CO₂ firefighting system efficiency (N-E – Not Effective, E – Effective) as elaborated from the investigation reports.

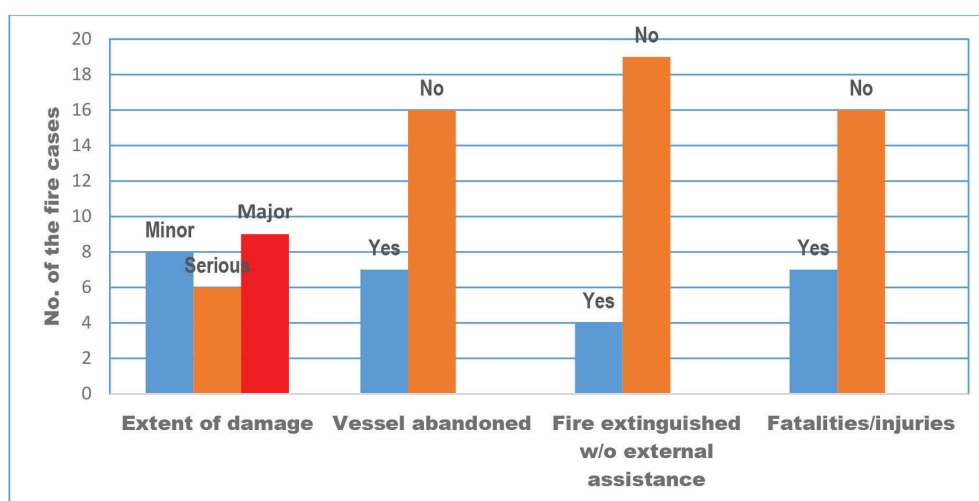
Figure 4 shows the overall efficiency of the fire extinguishing operation. The following four elements were analysed: the extent of damage, whether the ship was abandoned after the fire broke out due to the sudden escalation of fire and danger to human lives, whether the fire was extinguished by the crew or by external assistance (firefighting personnel, tugs, salvage teams, helicopters, etc.), and whether there were any deaths or injuries during firefighting operations.

The extent of damage to the ship and cargo is classified into three categories: minor, severe, and major. The number of damaged containers and the severity of structural damage to the ship was taken as the criteria for determining the degree of total damage caused by the fire. Damages up to 10 containers and damages to the ship's structure that can be repaired within one week are classified as minor. Damages from 10 to 100 containers and damages to the ship's structure requiring repair from one week to one month are classified as serious, while all damages requiring repair for a period longer than one month and if the number of damaged containers exceeds 100 are classified as major.

The ship was abandoned due to the sudden escalation of fire and danger to human lives in cases 1, 2, 4, 6, 17, 18 and 19.

Figure 4 Firefighting operations efficiency as elaborated from the investigation reports

The fire was extinguished by the crew without external assistance only in cases 3, 13, 21 and 23. In the cases where the fire was extinguished with external assistance, various resources were used, such as firefighting tugs, firefighters, firefighting planes, rescue vessels and helicopters, coastguard vessels, towing tugs, and salvage teams. The resources used in these cases range from one firefighting tug and firefighting team (case 5) to several firefighting tugs with firefighting teams, helicopters, two salvage companies and towing tugs (case 18).

Cases 1, 2, 15, 16, 18, 20 and 22 resulted in either dead or injured personnel. In case 2 there were 3 dead and 2 seriously injured crew members. Case 18, fire on MV Maersk Honam was one of the most devastating fires on container vessels up to date as it resulted in the loss of 5 crew members' lives and 22 crew members treated in the hospital. In case 22 more than 200 people were treated in the hospital due to respiratory problems. Injuries in cases 1, 15, 16 and 20 were limited to 1 to 3 persons who suffered burns and respiratory problems.
