Effect of Time-Real Marine Environment Exposure on the Mechanical Behavior of FRP Composites

Keywords: composites; sustainability of composites; marine environment; FRP composites

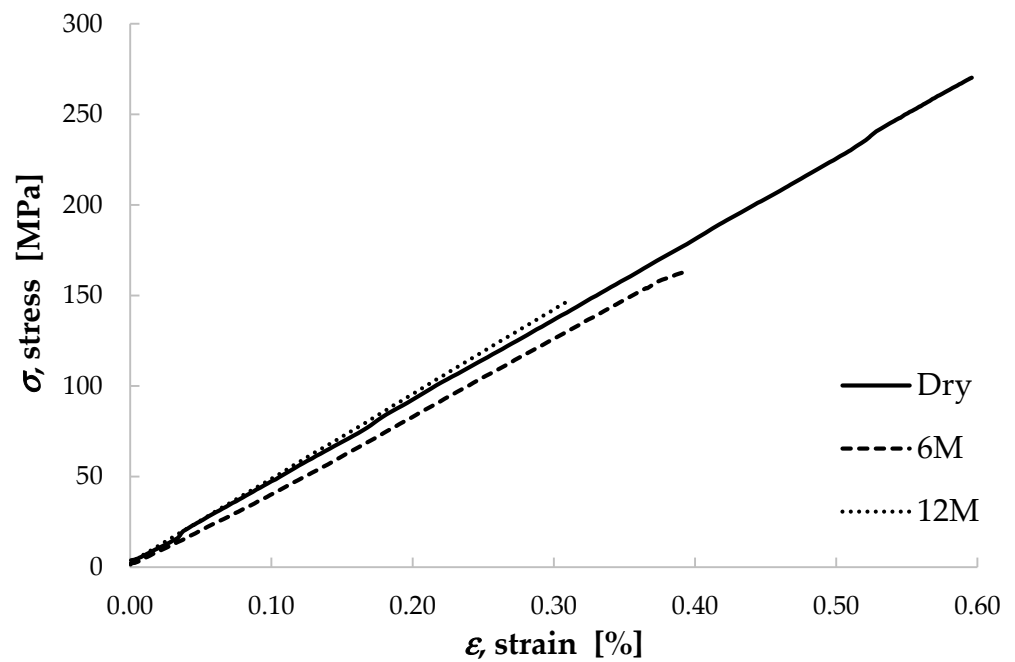
Figure 7. Engineering stress-strain diagrams for epoxy/glass UD0° coupons submerged in sea for 6 (6 M) and 12 months (12 M).

Engineering stress-strain diagrams were obtained from performed uniaxial tensile strength on dry coupons and wet coupons that were submerged in the sea for 6 and 12 months, Figures 7–12.

In all the diagrams in Figures 7–12, the reference stress-strain curve is designated as “Dry”. This curve represents the tensile mechanical properties of coupons not exposed to seawater. All submerged specimens had reduced tensile strength on average. Polyester resin coupons had a more pronounced drop in strength in the period from the 6th to the 12th month, Figure 13b, while the epoxy resin coupons exhibited greater tensile strength loss after the first 6 months of submersion. The only exception of this behavior was noticed in the epoxy coupons with the (0/90)s fiber layout configuration, Figure 14a. This is to be attributed to a single specimen from the group of this material and fiber layout combination submerged in the sea for 6 months exhibiting “extreme” tensile strength. By further examination, a higher fiber content in the said specimen was identified compared to that of the other specimens from the same group. This demonstrates that the manufacturing process has a strong impact on the mechanical properties of the finalized composite part.

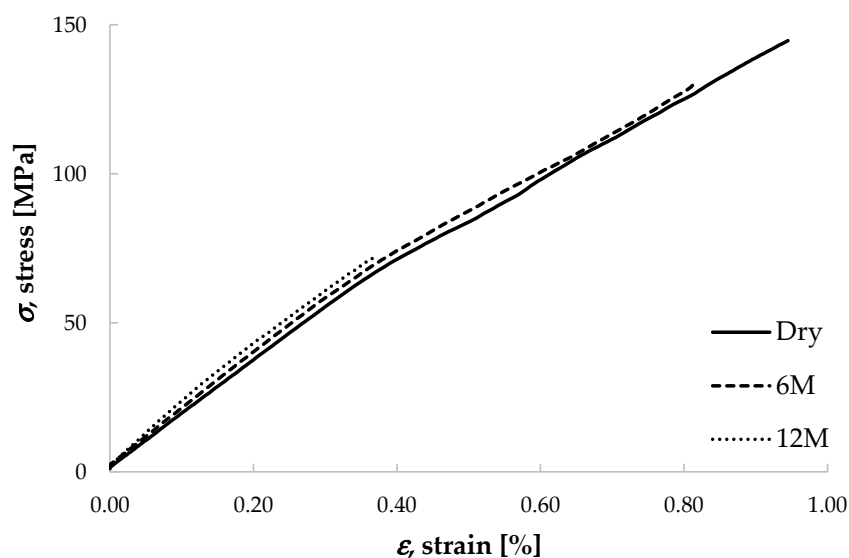
Figure 11. Engineering stress-strain diagrams for polyester /glass (0/90)s coupons submerged in sea for 6 (6 M) and 12 months (12 M).

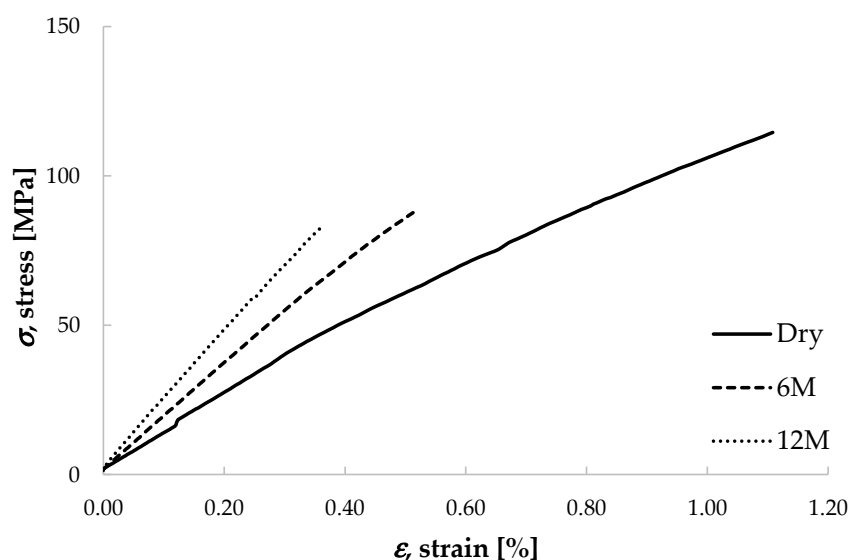
Figure 12. Engineering stress-strain diagrams for polyester /glass (0/45/90)s coupons submerged in sea for 6 (6 M) and 12 months (12 M).

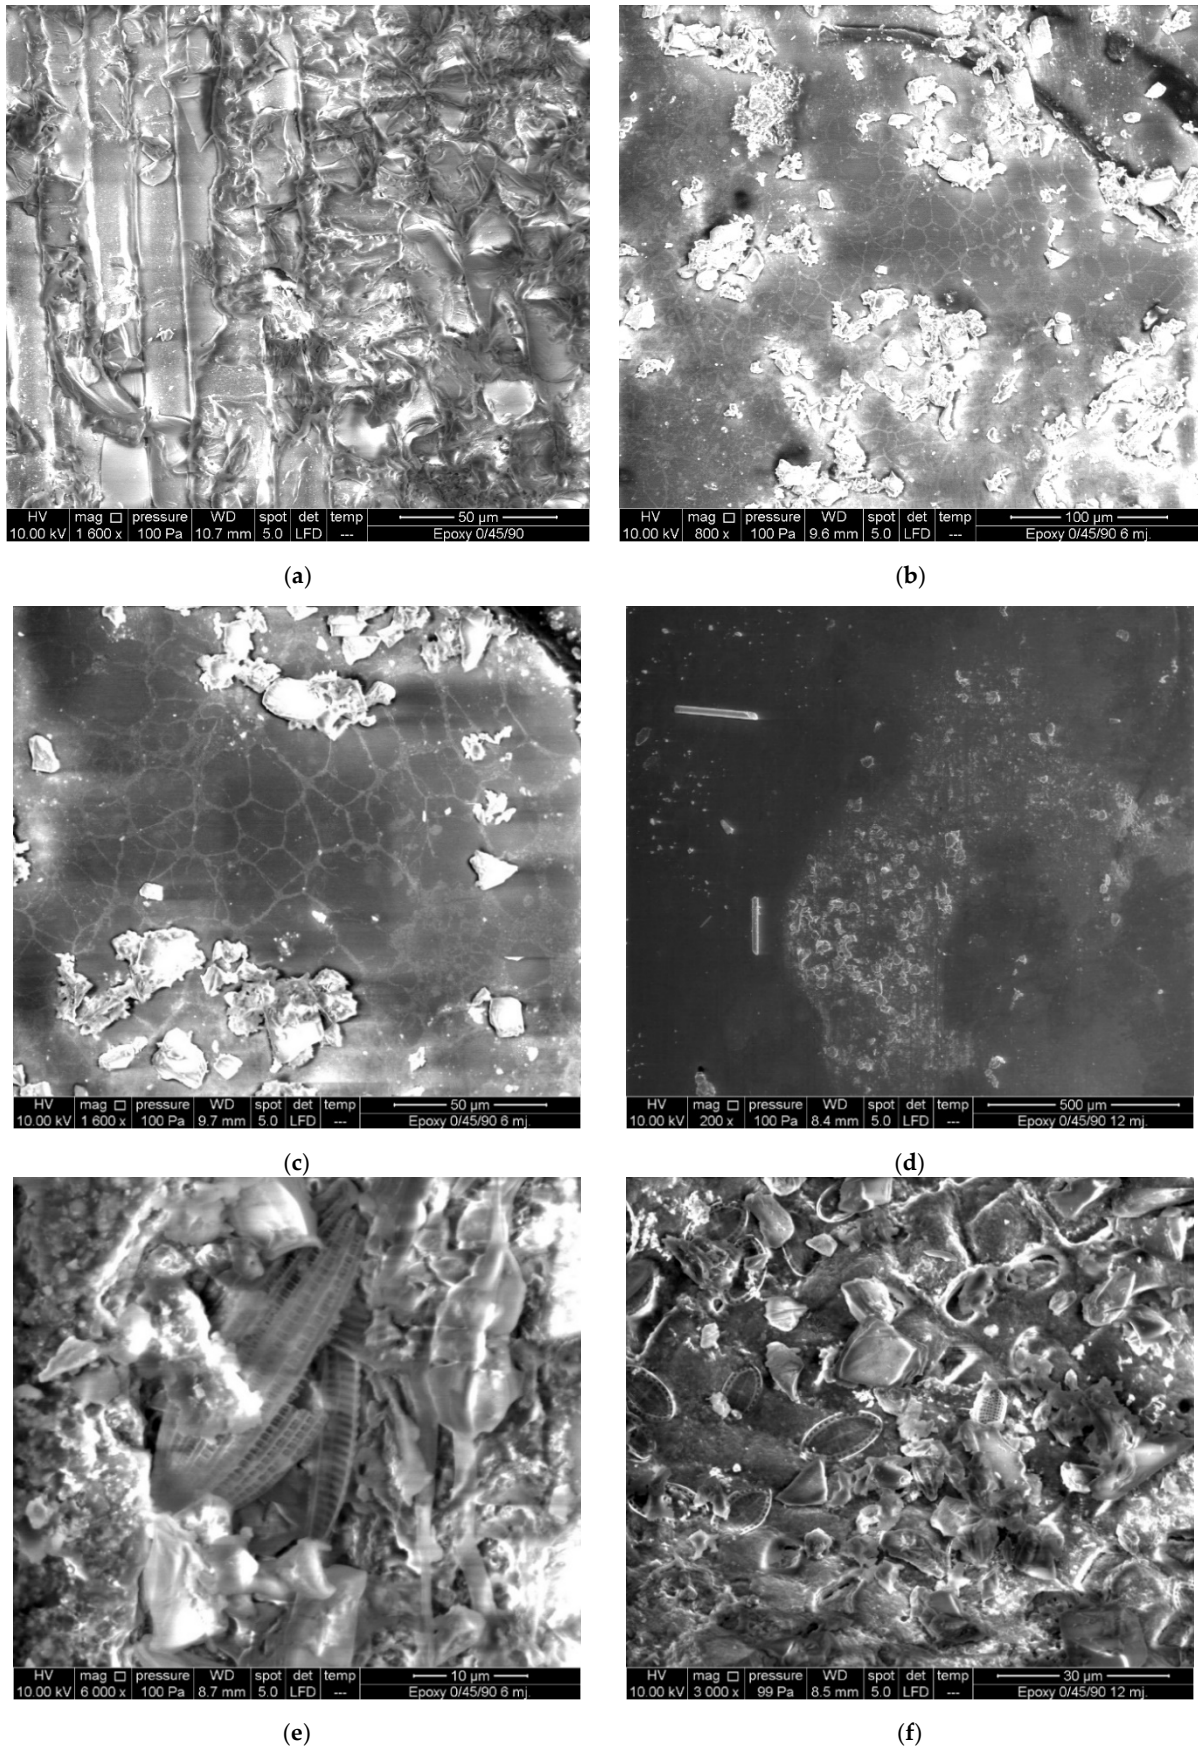
Figure 16. SEM epoxy (0/45/90)s: (a) dry; (b–d) salt crystals 6 and 12 months submersion; (e,f) microorganisms' growth after 6 and 12 months.

The images obtained by SEM investigation are presented in Figures 14–19. Only some representative images were chosen as a portrayal of the performed research to limit the length of the paper, whilst the complete set of all obtained images is posted on an online repository as Supplementary Materials to this article.

Analysis of the images collected during the microscopical investigation showed formation of salt crystals on the surface layers of the coupon as well as embedded salt crystals in both resins. The epoxy resin coupons showed a greater accumulation of salt crystals, Figures 14c, 15e and 16c, than polyester ones, Figures 17c, 18d and 19d, regardless of the fiber orientation setups.
