Effect of Time-Real Marine Environment Exposure on the Mechanical Behavior of FRP Composites

Keywords: composites; sustainability of composites; marine environment; FRP composites

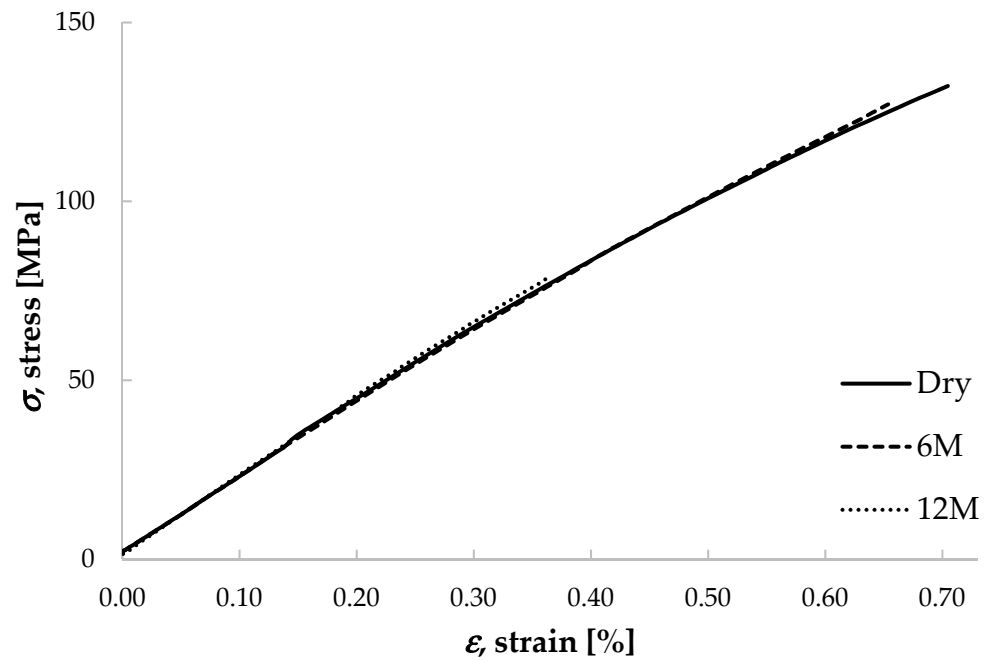
Figure 9. Engineering stress-strain diagrams for epoxy/glass (0/45/90)s coupons submerged in sea for 6 (6 M) and 12 months (12 M).

Engineering stress-strain diagrams were obtained from performed uniaxial tensile strength on dry coupons and wet coupons that were submerged in the sea for 6 and 12 months, Figures 7–12.

In all the diagrams in Figures 7–12, the reference stress-strain curve is designated as “Dry”. This curve represents the tensile mechanical properties of coupons not exposed to seawater. All submerged specimens had reduced tensile strength on average. Polyester resin coupons had a more pronounced drop in strength in the period from the 6th to the 12th month, Figure 13b, while the epoxy resin coupons exhibited greater tensile strength loss after the first 6 months of submersion. The only exception of this behavior was noticed in the epoxy coupons with the (0/90)s fiber layout configuration, Figure 14a. This is to be attributed to a single specimen from the group of this material and fiber layout combination submerged in the sea for 6 months exhibiting “extreme” tensile strength. By further examination, a higher fiber content in the said specimen was identified compared to that of the other specimens from the same group. This demonstrates that the manufacturing process has a strong impact on the mechanical properties of the finalized composite part.

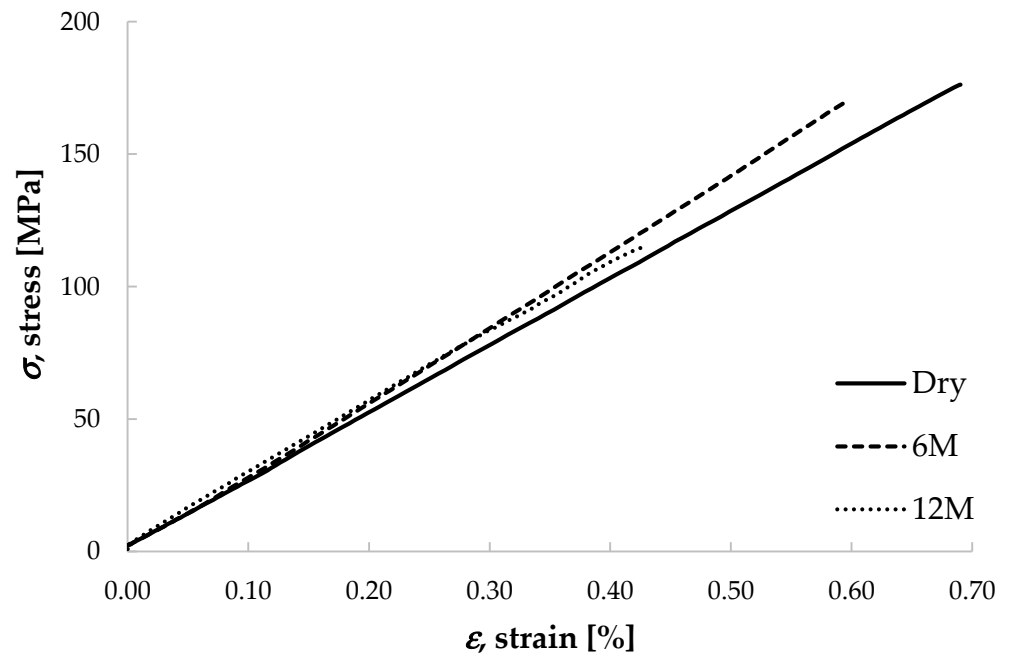
Figure 10. Engineering stress-strain diagrams for polyester/glass UD0° coupons submerged in sea for 6 (6 M) and 12 months (12 M).

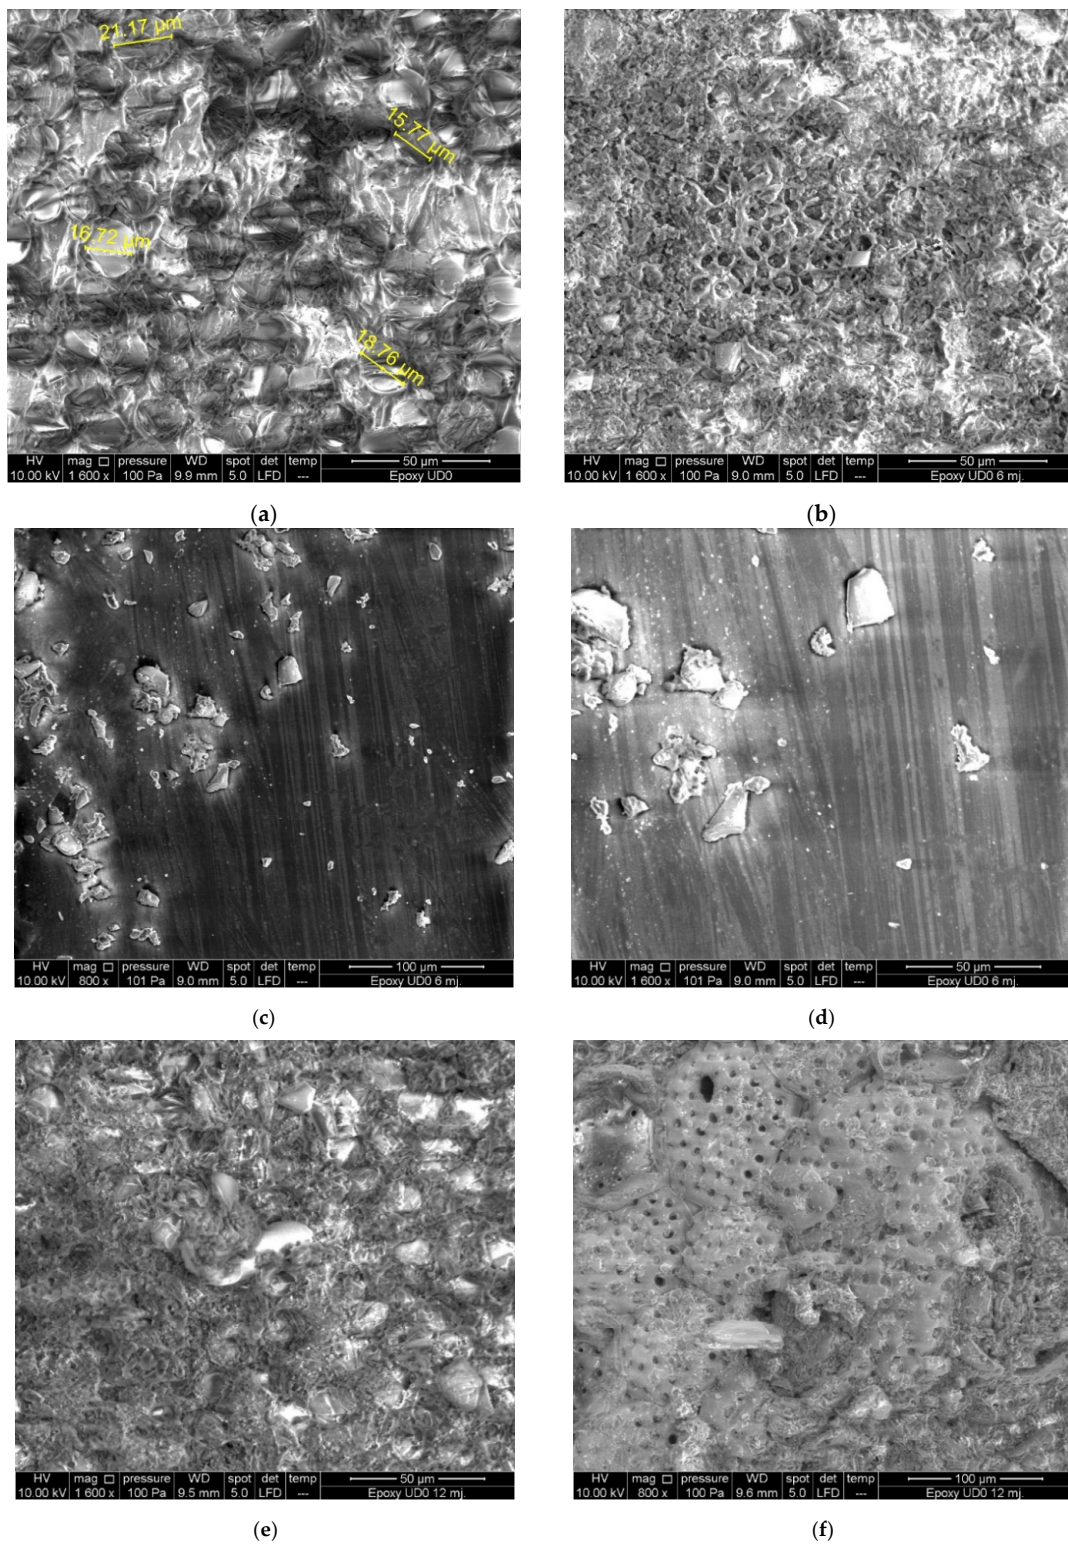
Figure 14. SEM epoxy UD0°: (a) dry; (b) 6 months submersion; (c,d) salt crystals after 6 months; (e,f) microorganisms' growth after 12 months.

The images obtained by SEM investigation are presented in Figures 14–19. Only some representative images were chosen as a portrayal of the performed research to limit the length of the paper, whilst the complete set of all obtained images is posted on an online repository as Supplementary Materials to this article.

Analysis of the images collected during the microscopical investigation showed formation of salt crystals on the surface layers of the coupon as well as embedded salt crystals in both resins. The epoxy resin coupons showed a greater accumulation of salt crystals, Figures 14c, 15e and 16c, than polyester ones, Figures 17c, 18d and 19d, regardless of the fiber orientation setups.
