# Analytical Research of the Container Ships Cargo Area Fires in the Period From 2010 to 2020

Review / Pregledni rad

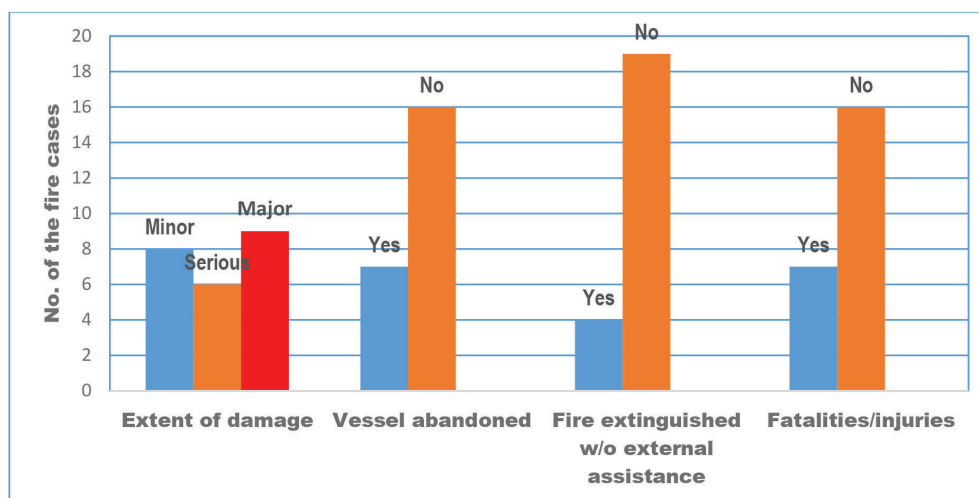
Figure 4 Firefighting operations efficiency as elaborated from the investigation reports

Figure 4 shows the overall efficiency of the fire extinguishing operation. The following four elements were analysed: the extent of damage, whether the ship was abandoned after the fire broke out due to the sudden escalation of fire and danger to human lives, whether the fire was extinguished by the crew or by external assistance (firefighting personnel, tugs, salvage teams, helicopters, etc.), and whether there were any deaths or injuries during firefighting operations.

The extent of damage to the ship and cargo is classified into three categories: minor, severe, and major. The number of damaged containers and the severity of structural damage to the ship was taken as the criteria for determining the degree of total damage caused by the fire. Damages up to 10 containers and damages to the ship's structure that can be repaired within one week are classified as minor. Damages from 10 to 100 containers and damages to the ship's structure requiring repair from one week to one month are classified as serious, while all damages requiring repair for a period longer than one month and if the number of damaged containers exceeds 100 are classified as major.

The ship was abandoned due to the sudden escalation of fire and danger to human lives in cases 1, 2, 4, 6, 17, 18 and 19.

Cases 1, 2, 15, 16, 18, 20 and 22 resulted in either dead or injured personnel. In case 2 there were 3 dead and 2 seriously injured crew members. Case 18, fire on MV Maersk Honam was one of the most devastating fires on container vessels up to date as it resulted in the loss of 5 crew members' lives and 22 crew members treated in the hospital. In case 22 more than 200 people were treated in the hospital due to respiratory problems. Injuries in cases 1, 15, 16 and 20 were limited to 1 to 3 persons who suffered burns and respiratory problems.
