Effect of Time-Real Marine Environment Exposure on the Mechanical Behavior of FRP Composites

Source / Izvornik: **Sustainability**, 2021, 13

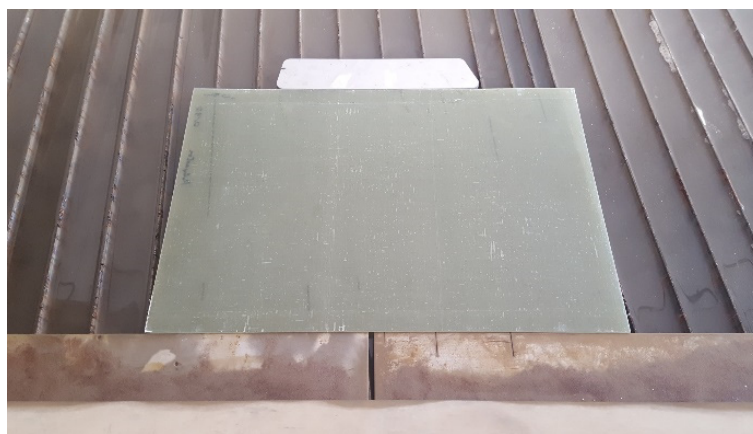
Three rectangular plates measuring 300 × 450 mm with three different layup schemes UD0, 0/90, (0/45/90), were produced for each of the material combinations using 8 plies of the UD fabric per plate, Figure 1. The epoxy/glass plates were produced by vacuum assisted infusion process, resulting in 3 ± 0.2 mm thick plates. The infusion process proved problematic for the polyester resin as it was resulting in dry fibers on the tool surfaces, so the polyester/glass plates were finally produced by hand layup process, resulting in 5 ± 0.5 mm thick plates.

Figure 1. Composite plate prepared for waterjet cutting.

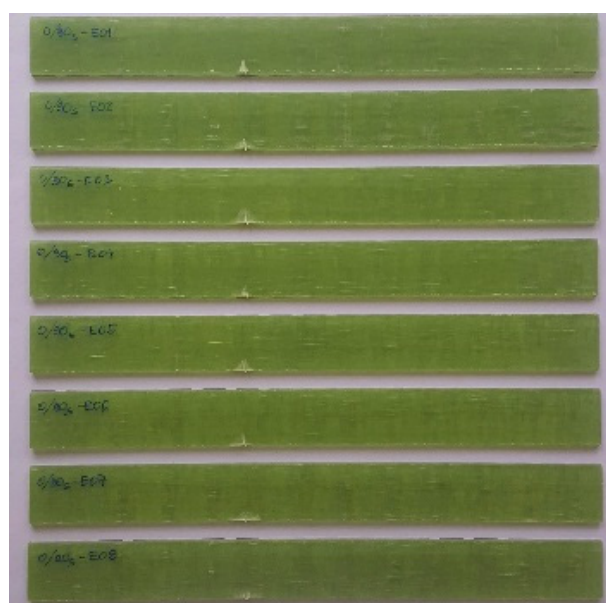
Coupons measuring 250 mm in length and 25 mm in width [33] were then cut out of the plates on a waterjet cutting machine (OMAX Maxiém series), Figure 2. The cutting pressure was between 1400 and 3400 bar, with the average cutting speed of 1187 mm/min.

Figure 2. Cut-out coupons.

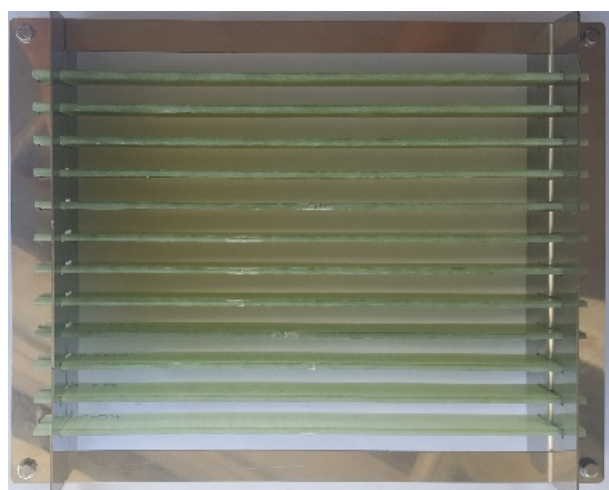
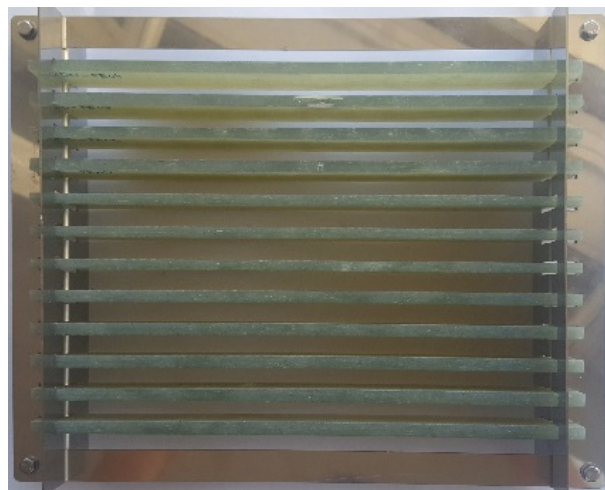
The other two subgroups were exposed to real-life sea environment, i.e., submerged into the sea on a depth of 10 m, at northern Adriatic in front of the city of Rijeka in Croatia for a duration of 6 and 12 months, respectively. The sea temperature at the location of experiment varies between 10–14 °C annually, salinity changes between 37.8–38.3 PPT, while the pH value is between 8.22–8.29 [35]. The coupons were mounted on special stainless-steel frames (AISI 316L), shown in Figure 3.

Figure 3. Coupons mounted on special stainless-steel frame before submersion: (a) epoxy/glass; (b) polyester/glass.

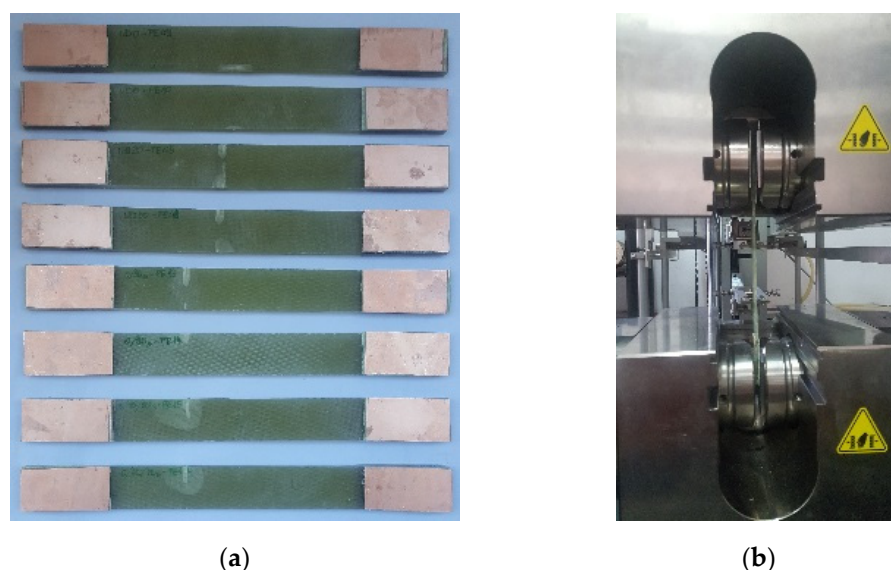
Reinforcement tabs, made of printed circuit board cutouts, were added at the coupon ends before the tensile test to minimize the influence of the grips pressure on the test results [36]. The size of the tabs was chosen based on ISO 527-4 recommendations, Figure 4.

Figure 4. Coupons: (a) with reinforcement tabs; (b) gripped in tensile testing machine.

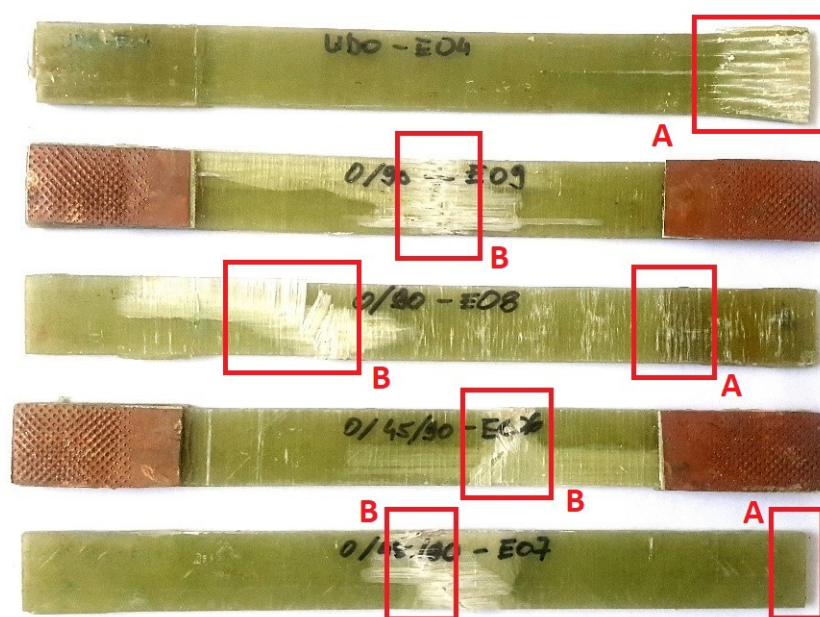
Microscopical investigation was performed on fractured coupons of three fiber layout configurations (UD0°, (0/90)s, (0/45/90)s) and for both dry coupons and coupons submerged in the sea for different periods i.e., 6 and 12 months. Surface and cross-sectional images were taken of all coupons, with special attention given to the grips areas (A) and locations with observed damage after the tensile test (B), Figure 5.

Figure 5. Coupons after tensile testing; locations for microscopical examination.

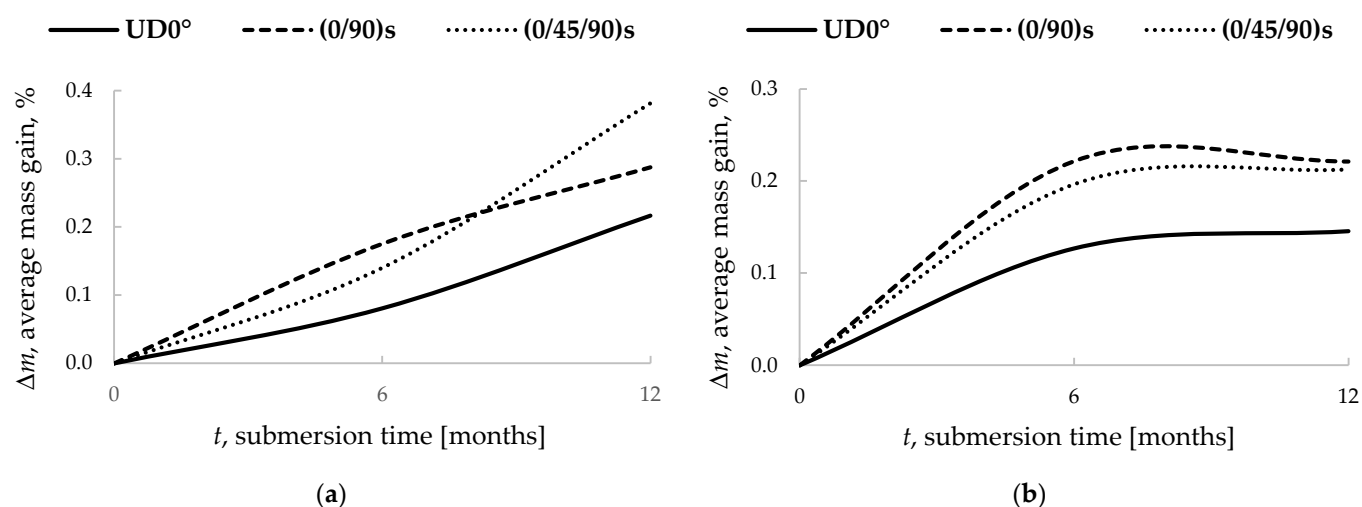
The cleaned coupons' mass measurement results after the period of 6 and 12 months of submersion are shown below, Figure 6.

Figure 6. Average mass gain due to seawater absorption: (a) epoxy resin; (b) polyester resin.

The mass measurement of all coupons before and after the submersion showed an increase of mass for all coupons, Tables 3 and 4, Figure 6. The epoxy resin coupons showed a greater average mass gain due to water absorption compared to polyester ones. Of the total of six resin material/fiber layout configurations, epoxy coupons with (0/90)s layout and all of the polyester coupons showed signs of water absorption saturation in the one year period. The epoxy UD0° and (0/45/90)s fiber layout have still and rising mass gain curve, indicating that water absorption saturation was not achieved after one year of submersion, Figure 6a. The (0/45/90)s fiber layout configuration coupons for both resin types showed the greatest mass gain compared to that of the other fiber layout configurations.

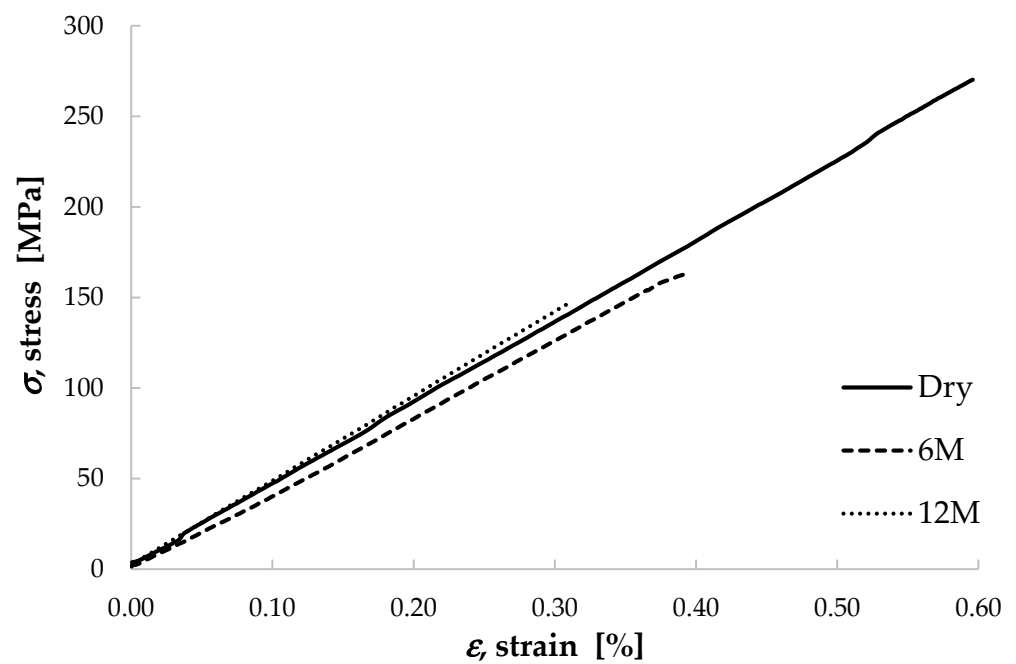
Figure 7. Engineering stress-strain diagrams for epoxy/glass UD0° coupons submerged in sea for 6 (6 M) and 12 months (12 M).

Engineering stress-strain diagrams were obtained from performed uniaxial tensile strength on dry coupons and wet coupons that were submerged in the sea for 6 and 12 months, Figures 7–12.

In all the diagrams in Figures 7–12, the reference stress-strain curve is designated as “Dry”. This curve represents the tensile mechanical properties of coupons not exposed to seawater. All submerged specimens had reduced tensile strength on average. Polyester resin coupons had a more pronounced drop in strength in the period from the 6th to the 12th month, Figure 13b, while the epoxy resin coupons exhibited greater tensile strength loss after the first 6 months of submersion. The only exception of this behavior was noticed in the epoxy coupons with the (0/90)s fiber layout configuration, Figure 14a. This is to be attributed to a single specimen from the group of this material and fiber layout combination submerged in the sea for 6 months exhibiting “extreme” tensile strength. By further examination, a higher fiber content in the said specimen was identified compared to that of the other specimens from the same group. This demonstrates that the manufacturing process has a strong impact on the mechanical properties of the finalized composite part.

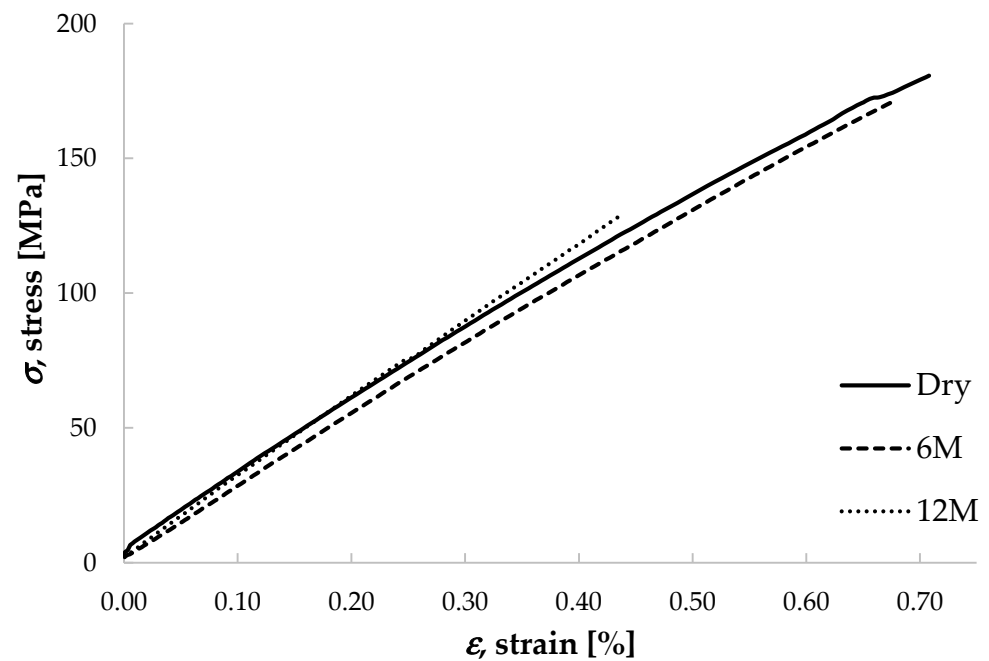
Figure 8. Engineering stress-strain diagrams for epoxy/glass (0/90)s coupons submerged in the sea for 6 (6 M) and 12 months (12 M).

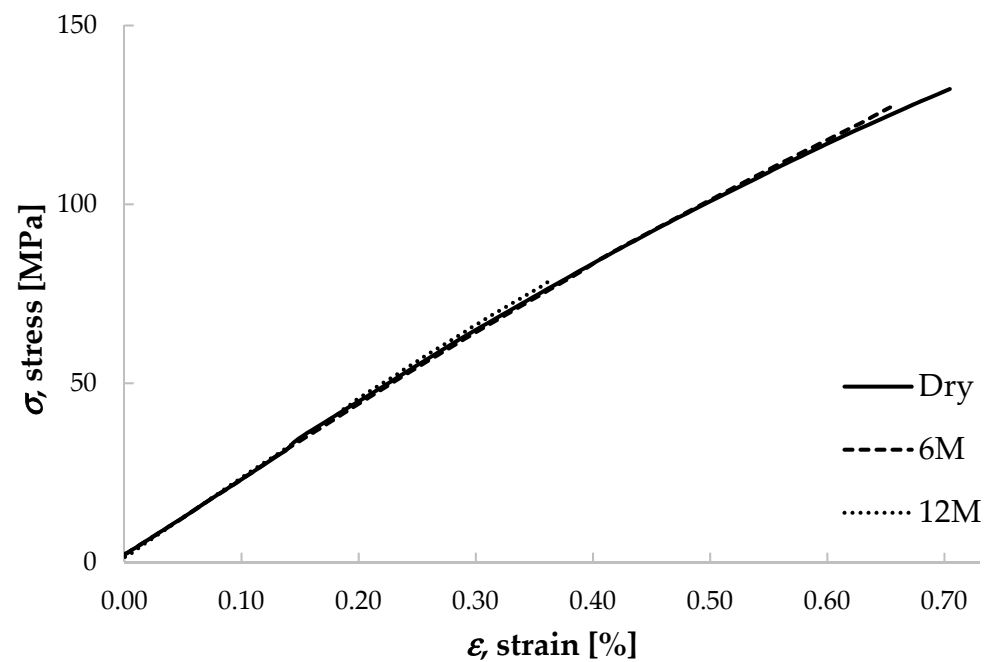
Figure 9. Engineering stress-strain diagrams for epoxy/glass (0/45/90)s coupons submerged in sea for 6 (6 M) and 12 months (12 M).

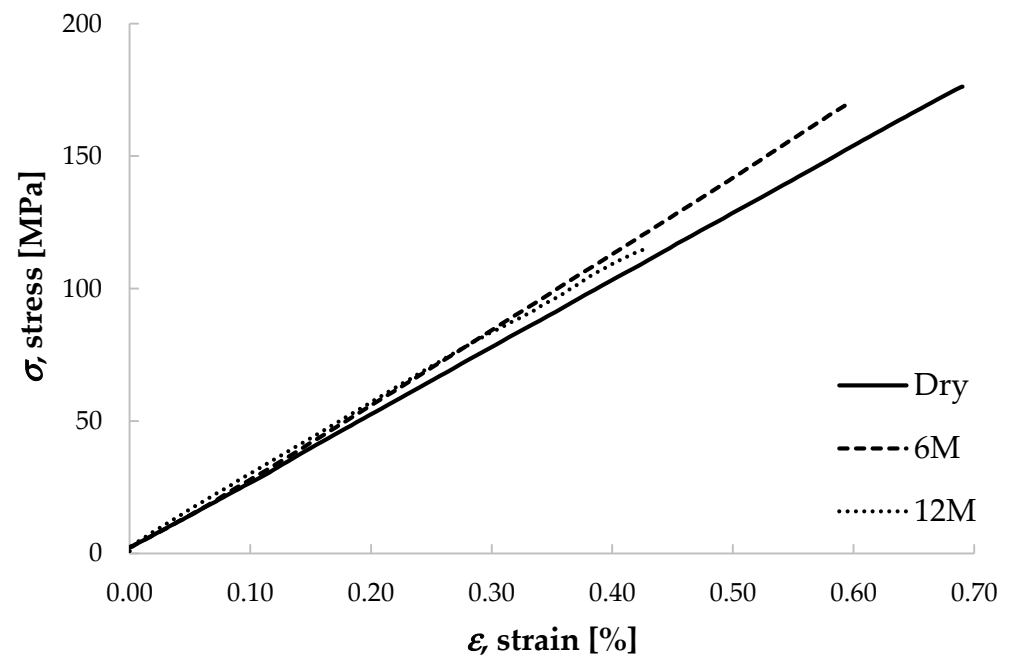
Figure 10. Engineering stress-strain diagrams for polyester/glass UD0° coupons submerged in sea for 6 (6 M) and 12 months (12 M).

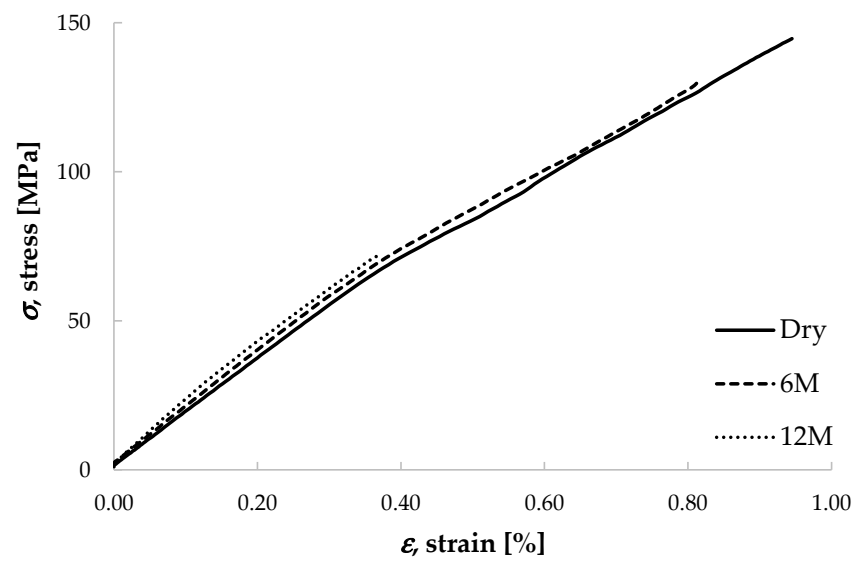
Figure 11. Engineering stress-strain diagrams for polyester /glass (0/90)s coupons submerged in sea for 6 (6 M) and 12 months (12 M).

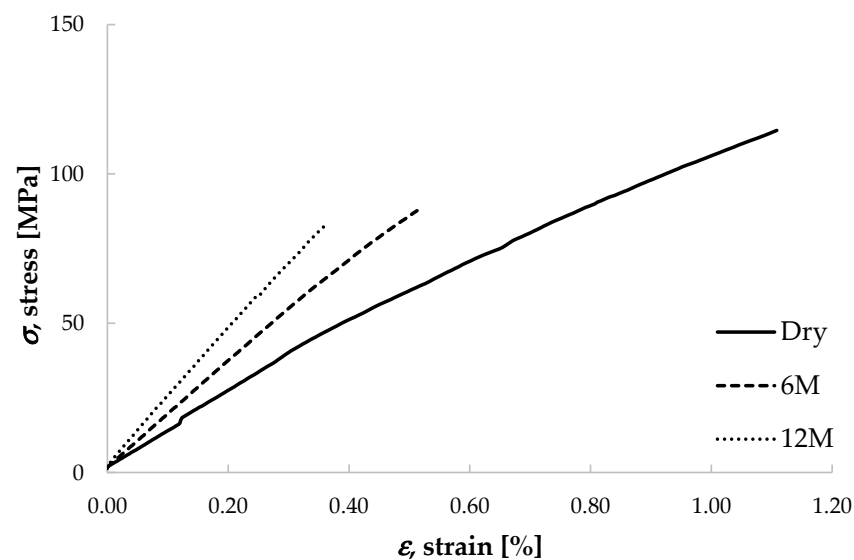
Figure 12. Engineering stress-strain diagrams for polyester /glass (0/45/90)s coupons submerged in sea for 6 (6 M) and 12 months (12 M).

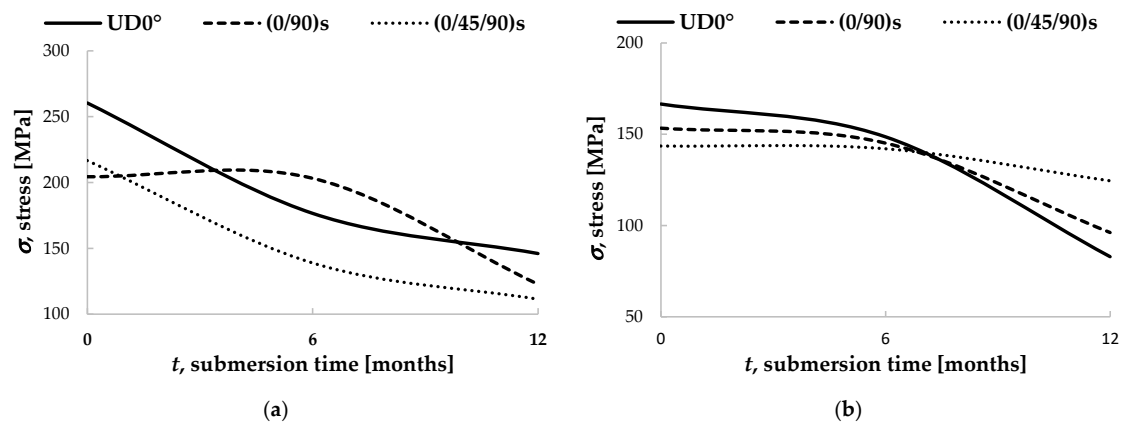
Figure 13. Average tensile strength degradation: (a) epoxy resin coupons; (b) polyester resin coupons.

The change in tensile strength due to the prolonged submersion in seawater is shown in Figures 13 and 14.

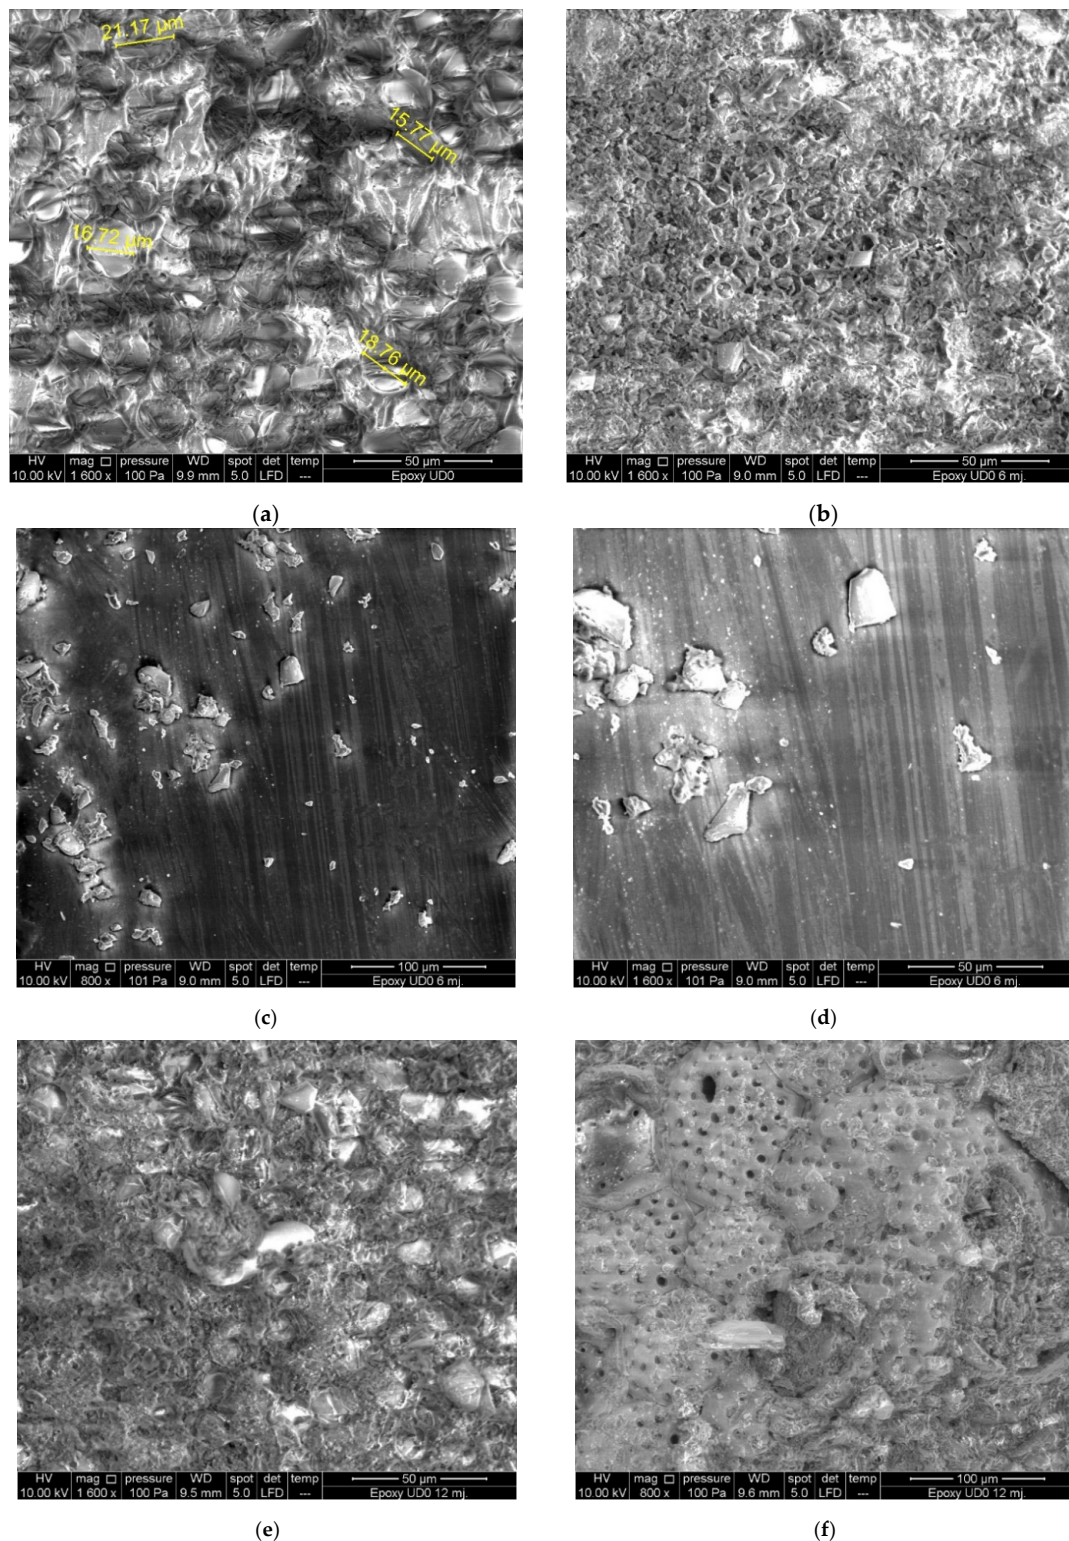
Figure 14. SEM epoxy UD0°: (a) dry; (b) 6 months submersion; (c,d) salt crystals after 6 months; (e,f) microorganisms' growth after 12 months.

The images obtained by SEM investigation are presented in Figures 14–19. Only some representative images were chosen as a portrayal of the performed research to limit the length of the paper, whilst the complete set of all obtained images is posted on an online repository as Supplementary Materials to this article.

Analysis of the images collected during the microscopical investigation showed formation of salt crystals on the surface layers of the coupon as well as embedded salt crystals in both resins. The epoxy resin coupons showed a greater accumulation of salt crystals, Figures 14c, 15e and 16c, than polyester ones, Figures 17c, 18d and 19d, regardless of the fiber orientation setups.

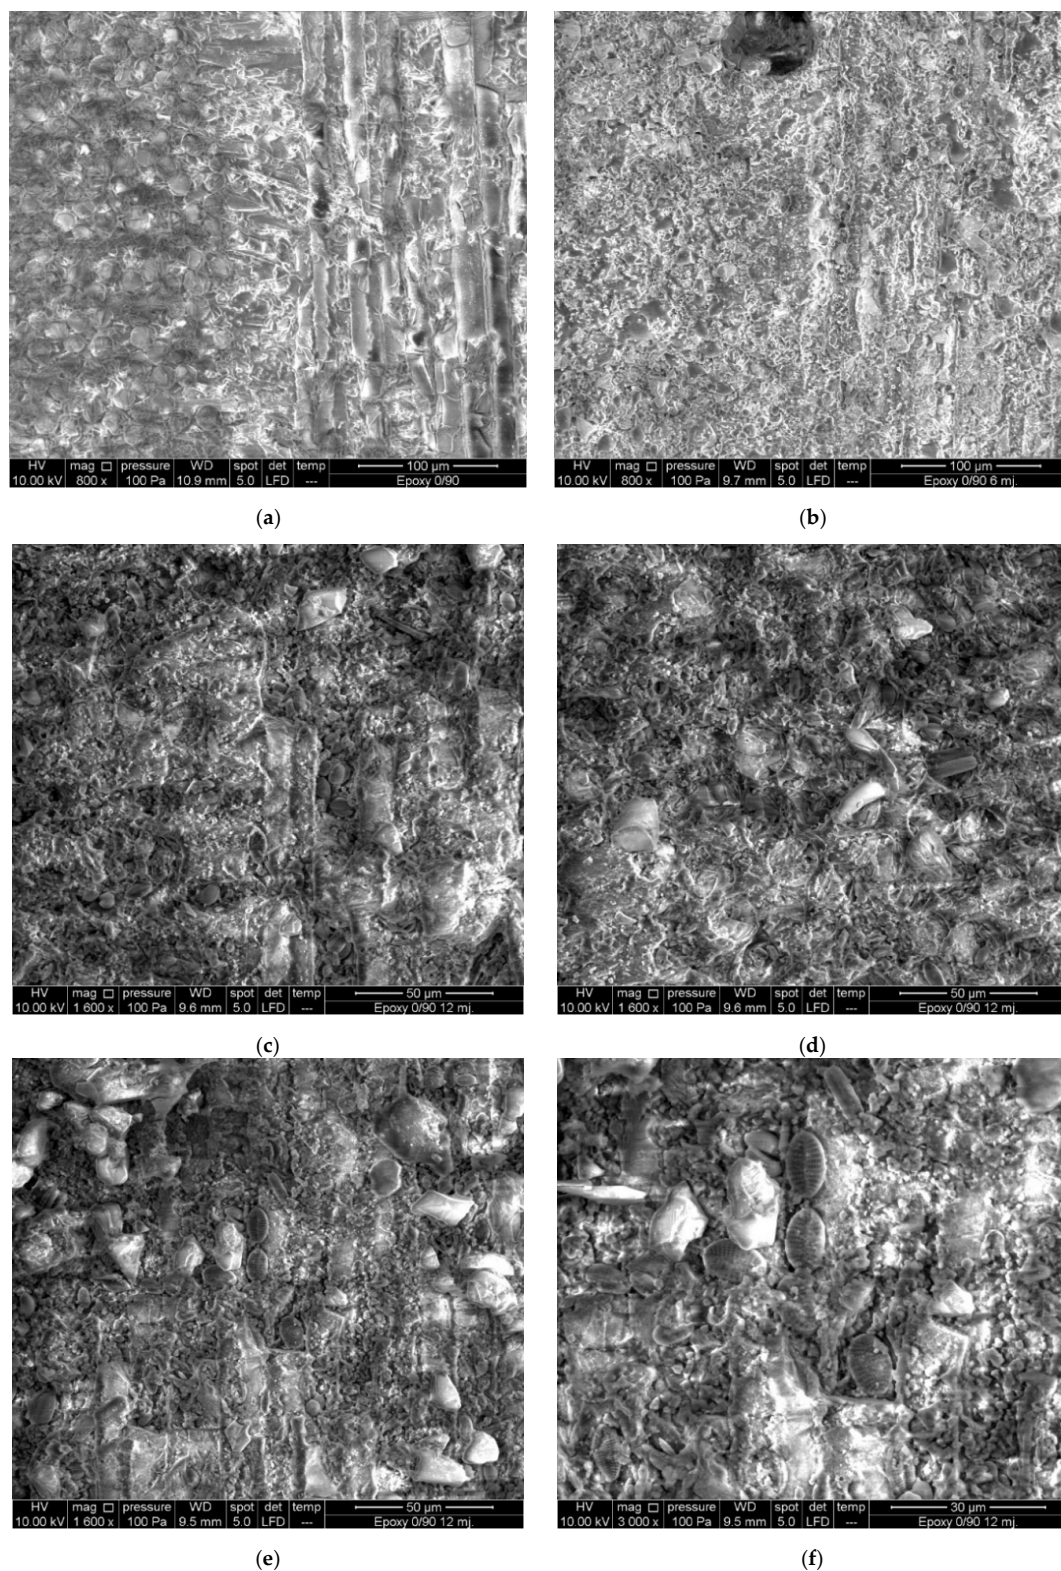
Figure 15. SEM epoxy (0/90)s: (a) dry; (b) 6 months submersion; (c,d) salt crystal formations; (e,f) microorganisms' growth after 12 months.

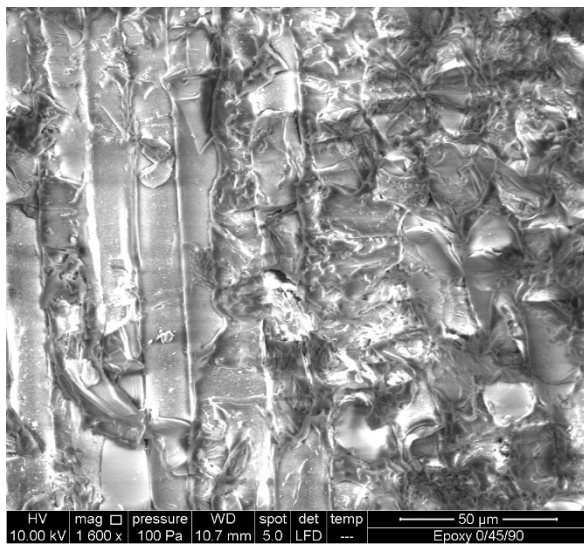
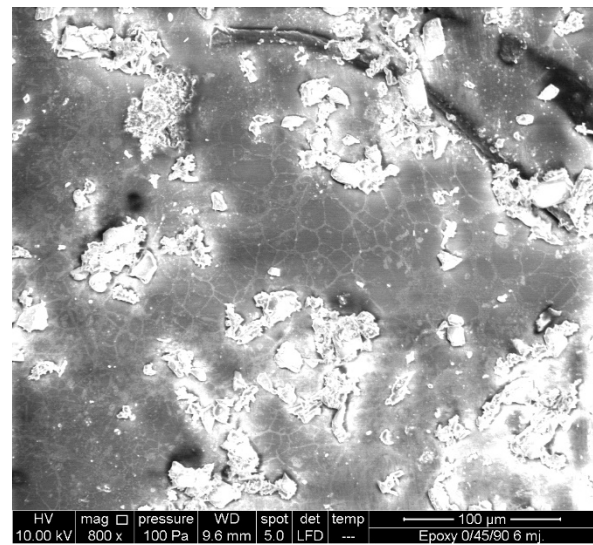
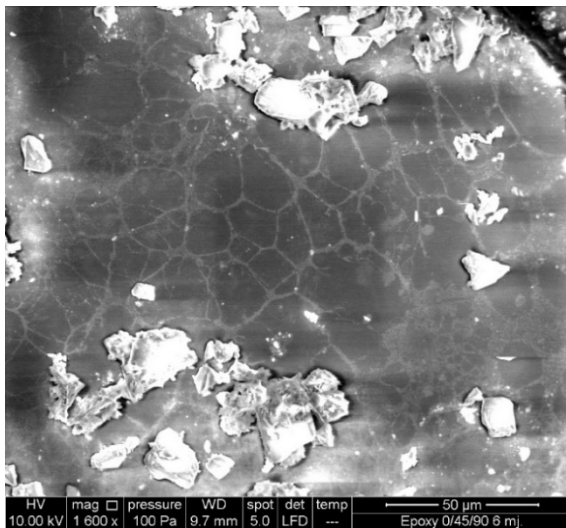
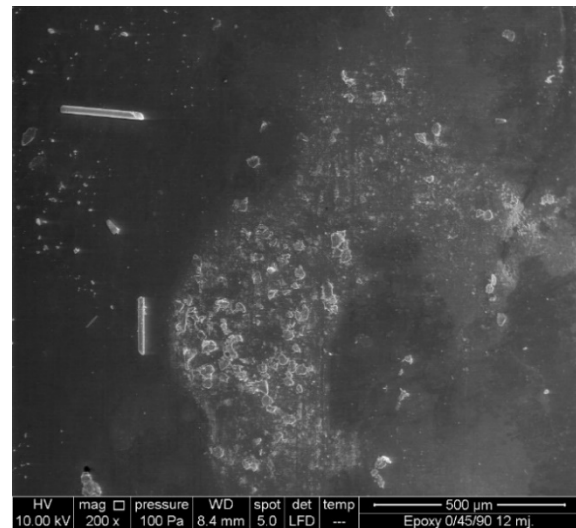
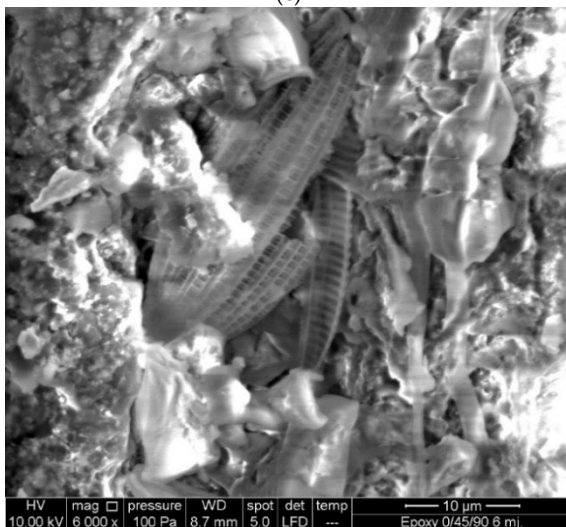
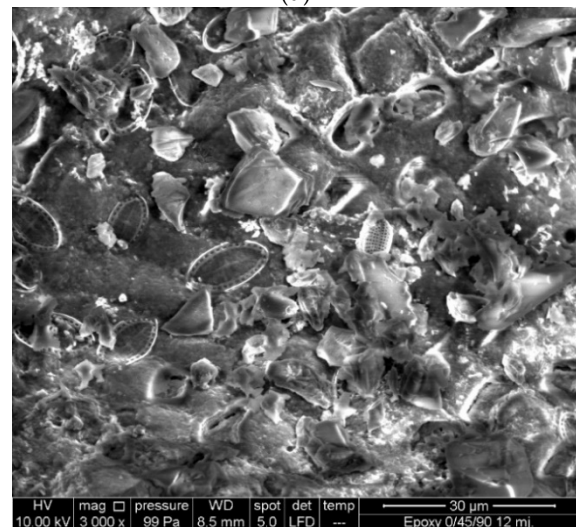
Figure 16. SEM epoxy (0/45/90)s: (a) dry; (b–d) salt crystals 6 and 12 months submersion; (e,f) microorganisms' growth after 6 and 12 months.

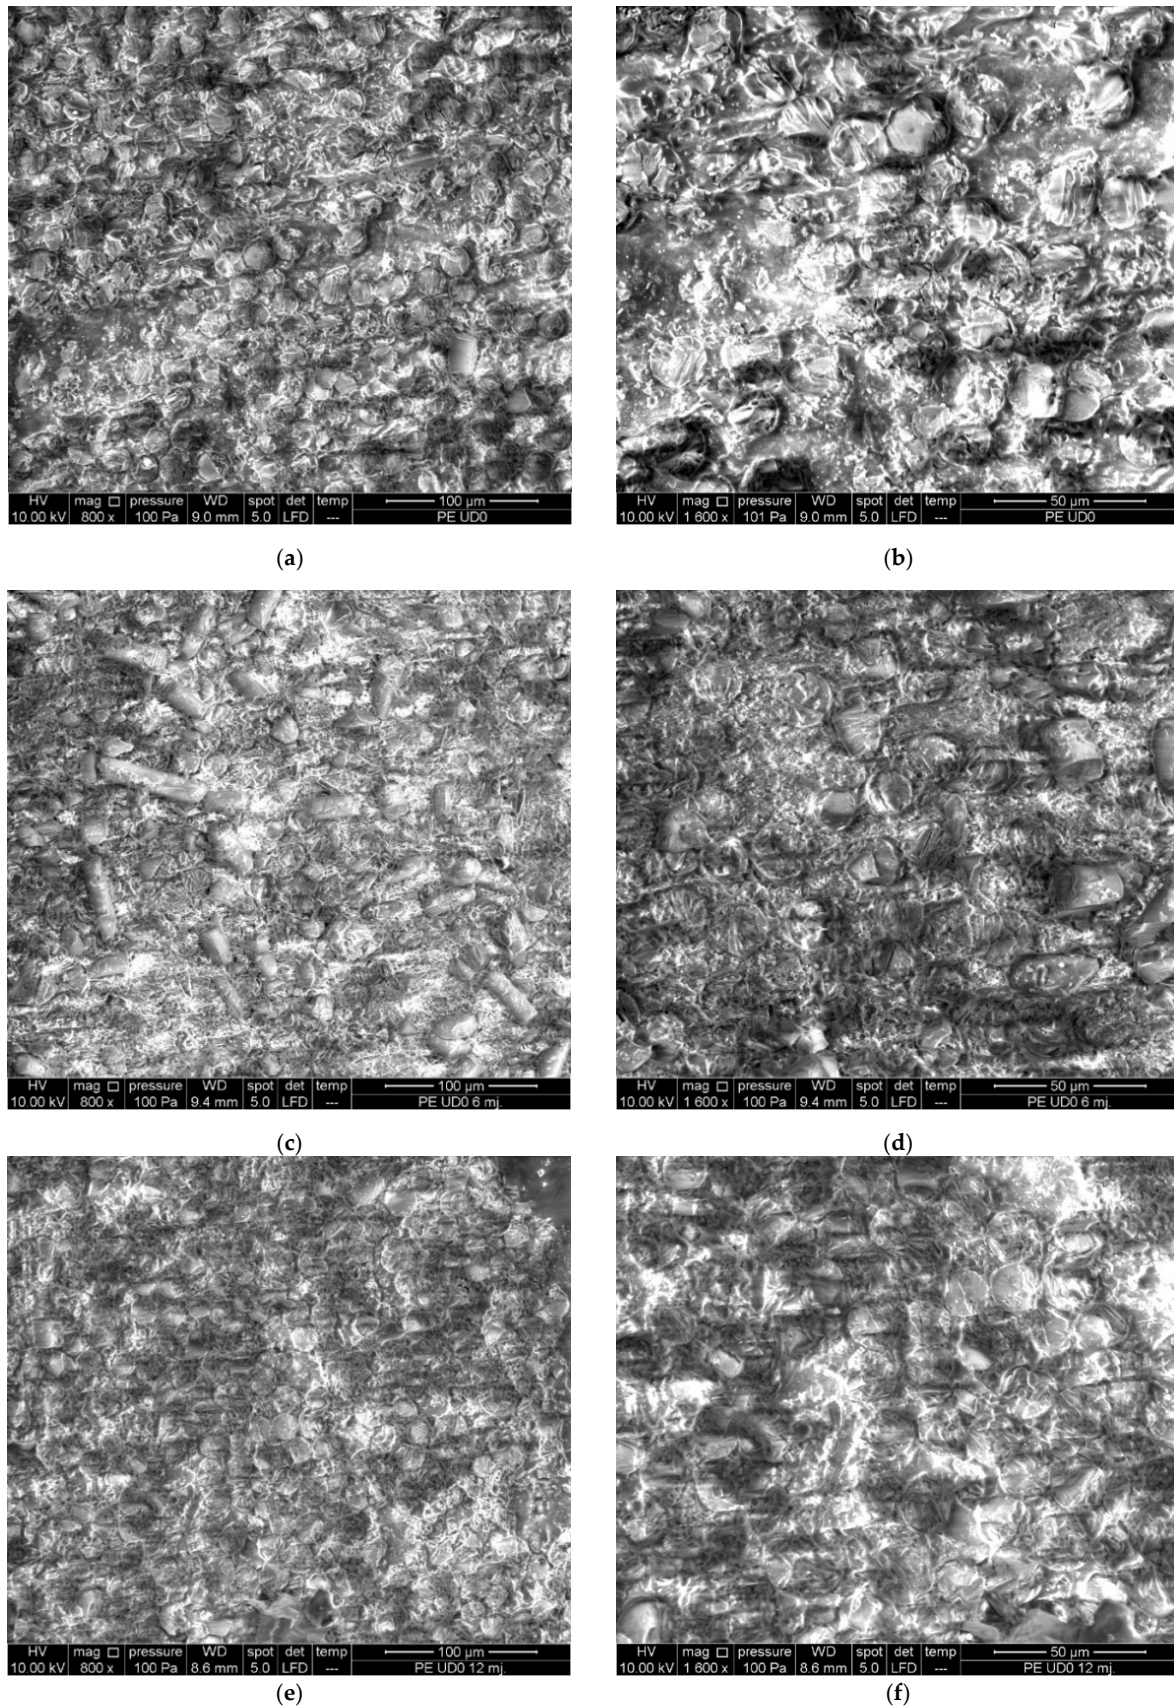
Figure 17. SEM polyester UD0°: (a,b) dry; (c,d) salt crystals 6 months submersion; (e,f) 12 months submersion.

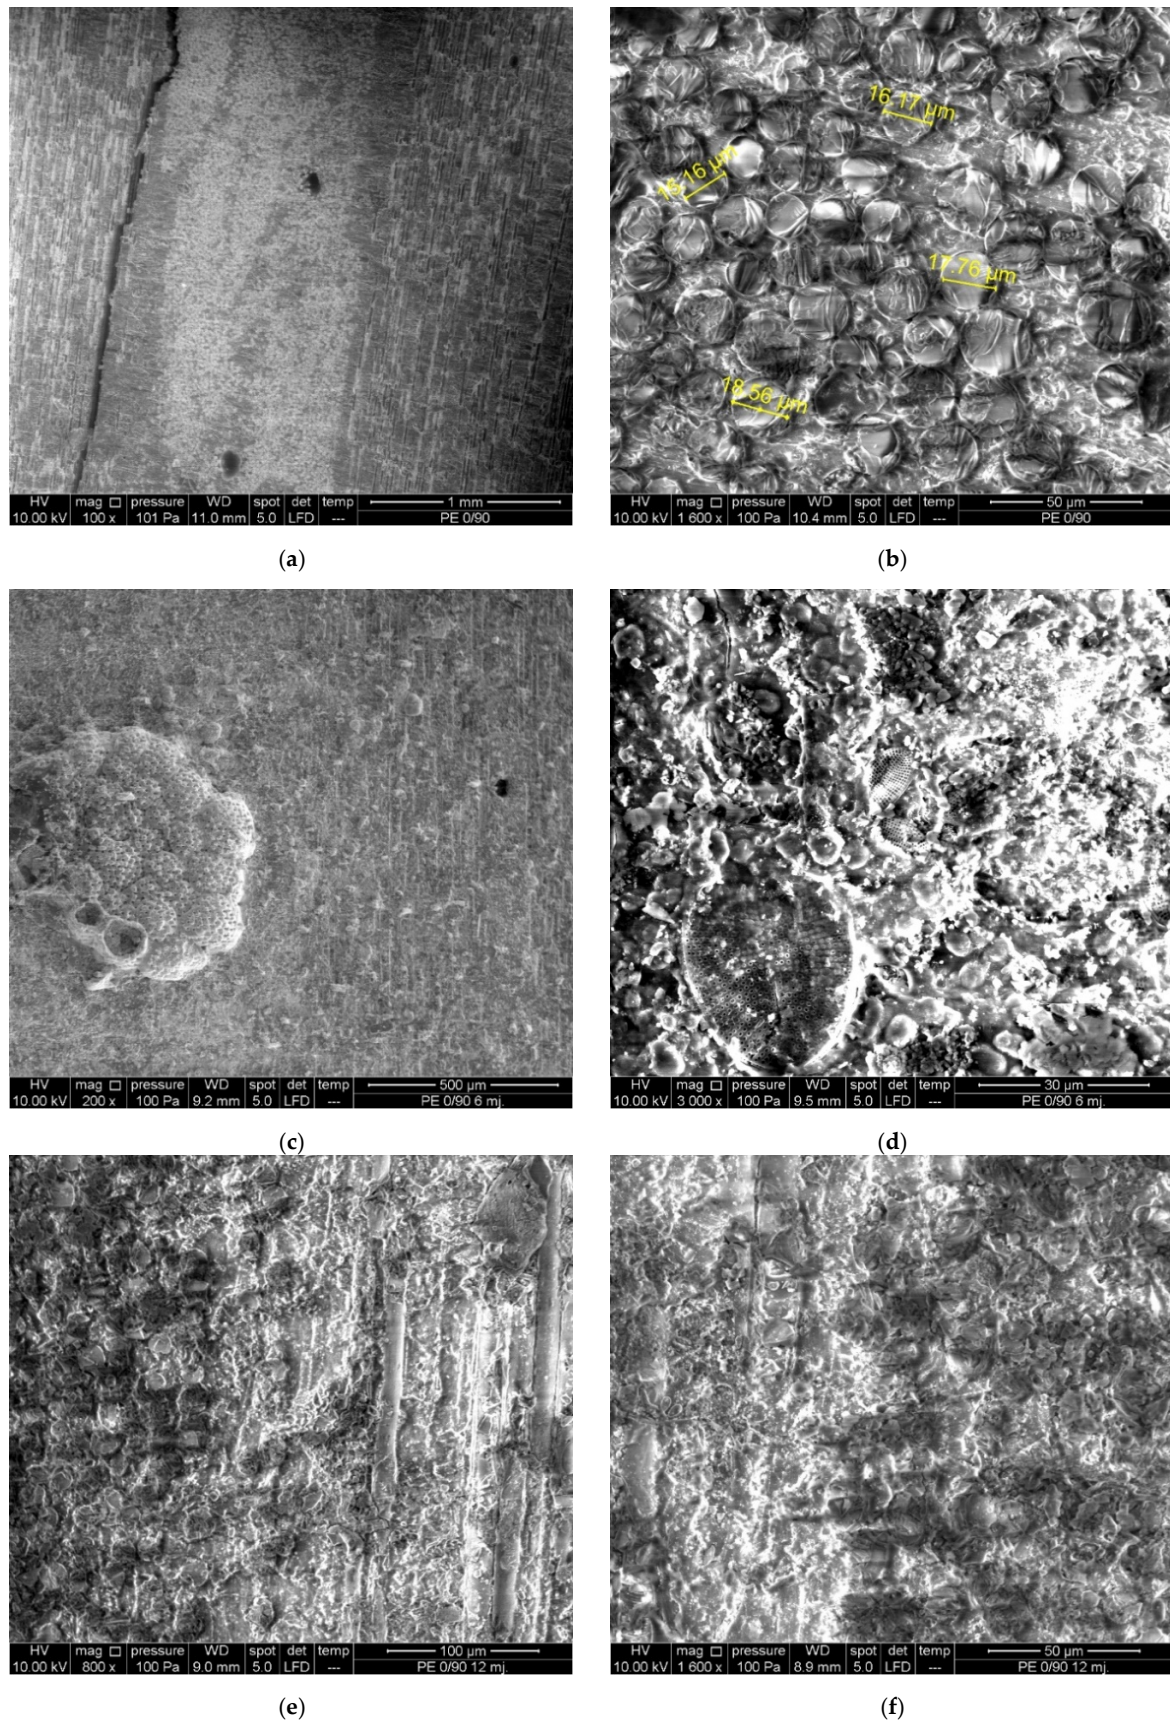
Figure 18. SEM polyester (0/90)s: (a,b) dry, manufacturing imperfections; (c,d) microorganisms' growth after 6 months of submersion; (e,f) 12 months of submersion.
