# Common failures of ship propulsion shafts

Source / Izvornik: **Pomorstvo, 2017, 31, 85 - 90**

**Journal article, Published version**

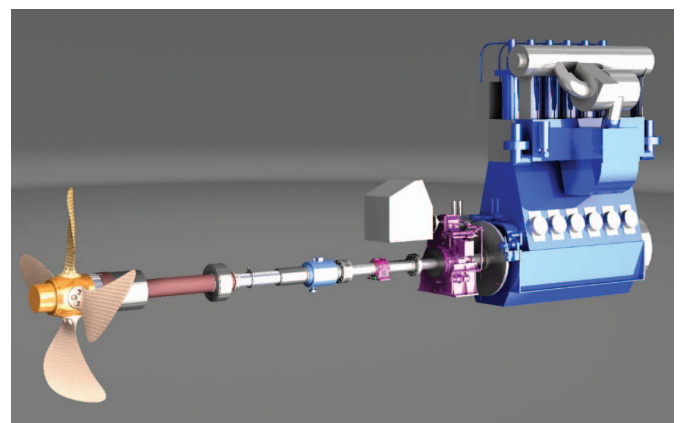
**Figure 1** Typical Ship Propulsion System Elements Rendering

The propulsion system has a pivotal role on board ships. A typical marine propulsion system is comprised of the following main parts: main engine, driving device, marine shaft and propeller as shown in Figure 1. As far as fatigue is concerned, the main engine is a complex unit for itself. It represents a vibrations source (impulse operation) for the entire ship and the propulsion system as well. Here, the propulsion shaft will be discussed more in detail.

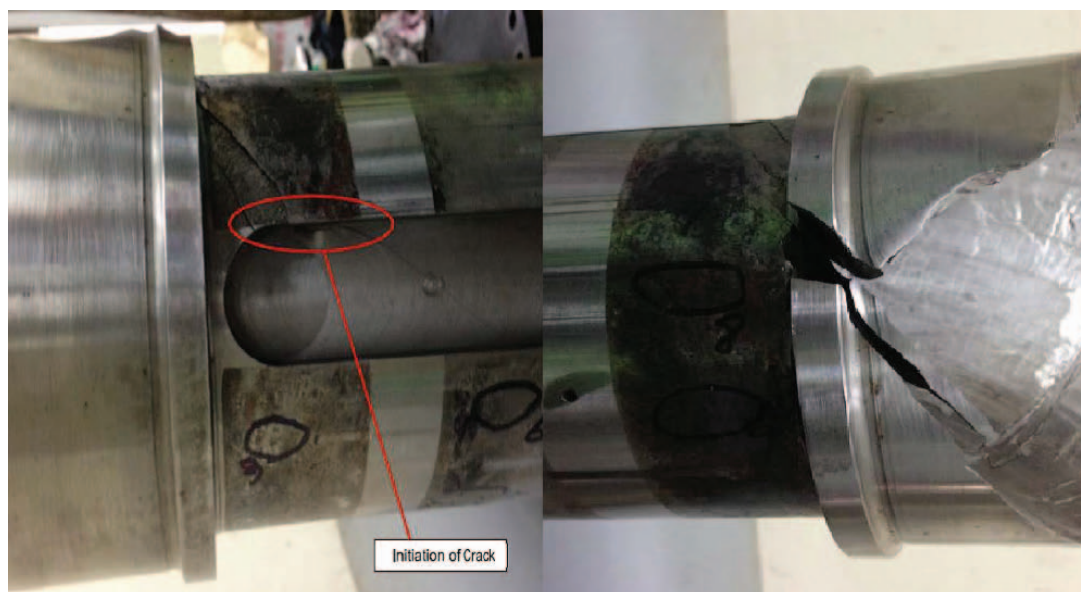
Figure 3 The Characteristic Torsional Failure Crack Shape [8]

The geometry of the ends of keyways represents a stress concentration factor in the cases of torque transmission through shaft keys for dynamic vibrational loads. Faulty machining of shaft key elements (key groove, keyway and key) geometry, inadequate run out radii or material imperfection can be root causes of torsional fatigue failure in shaft keys. The characteristic torsional failure indicator is the crack pattern that initiates at the end of the keyway and propagates in a 45° rotational direction in a helical shape, shown in Figure 3.

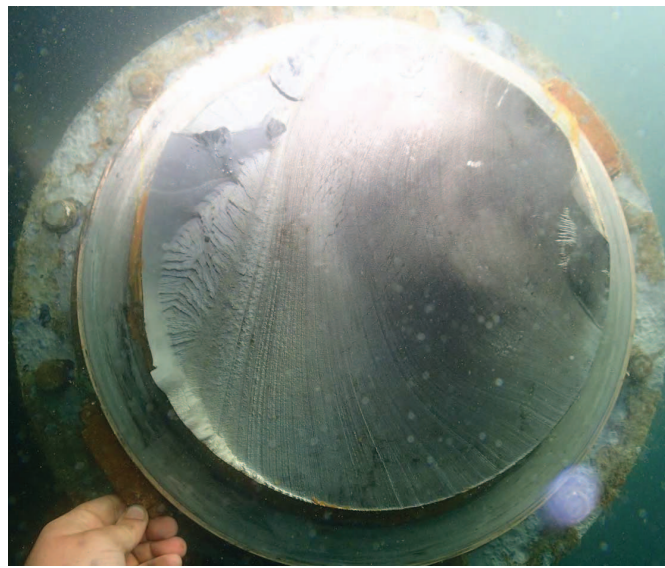
Figure 7 Uniaxial Fatigue Failure Crack Shape [15]

Abnormal performance of the propeller by way of one non-performing malformed blade can generate a uniaxial force which fluctuates once per rotation in a consistent transverse direction across the shaft. The fluctuating force generates a couple which can cause fatigue failure of the propeller hub [15]. Uniaxial type of failure is characterized by a fatigue fracture with a single origination point that progresses across the shaft from the side where the force is being applied and results in the final overload failure occurring on the opposite side from the fluctuating force.
