Evaluation of the Corrosion Depth of Double Bottom Longitudinal Girder on Aging Bulk Carriers

Abstract: The longitudinal girder (LG) between fuel oil tanks (FOT) and water ballast tanks in the double bottoms of ships represent critical structural parts whose watertight nature could be harmed by corrosion, thus, causing the pollution of water ballast tanks and adjacent areas. The new common structural rules (CSR) define the minimum thickness values of structural elements and corrosion margins. The assessment of the deviations from the prescribed values during ship operation could optimize the prescribed criteria. Assuming that corrosive processes begin after four years of operation, the paper analyzes a linear model that describes the percentage of plate wear as a function of the built-in thickness of LG of FOT. The research included 20 ships and provided the database for 1918 corrosion depth values. The gauging records included the average values of the original thickness of steel plates grouped in three intervals (11–13 mm, 13–15 mm, 15–18 mm). Based on the difference between the built-in and subsequently measured values, the paper analyzes the percentage of thickness reduction d

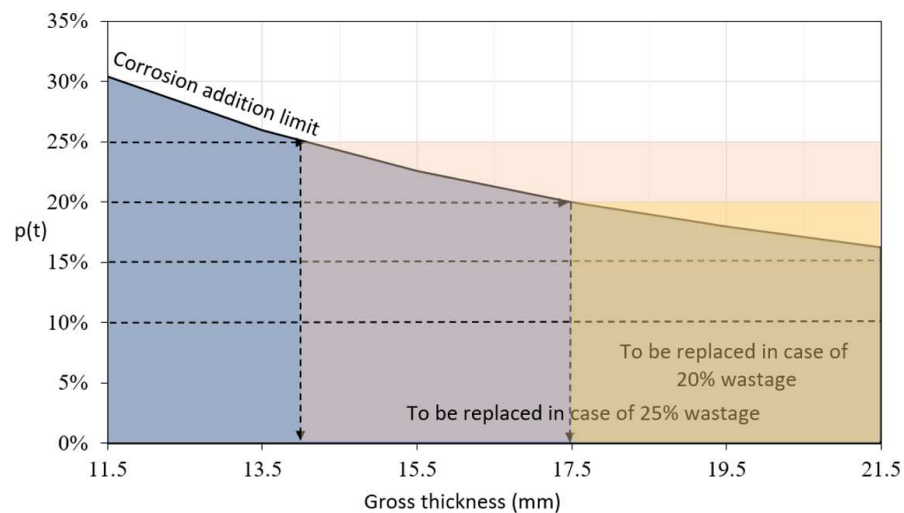
According to Table 2, the design values of corrosion addition and corresponding gross thicknesses are illustrated in Figure 1, considering the most common criteria for plating replacement (shaded areas)—10%, 15%, 20%, and 25% of corrosive wear, labeled here as $p(t)$ and expressed in %. Assuming that the strict criteria of 10% or 15% of corrosive wear are reached, thinner plates would have a larger margin before they reach the corrosion addition limit and net thickness. On the other hand, plating whose thickness is 21.5 mm would have a margin of only 2% (in case of 15% wear).

Figure 1. Gross thickness and corrosion addition percentage plotted against the corrosion wear percentage of gross thickness with corresponding criteria for the LG of bulk carriers.

Considering less strict criteria, such as 25% of wear, all the plates whose thickness exceeds 14 mm of gross thickness would have to be replaced, whereas, in the case of 20% of allowable wear, only the plates that are more than 17.5 mm thick would have to be removed.

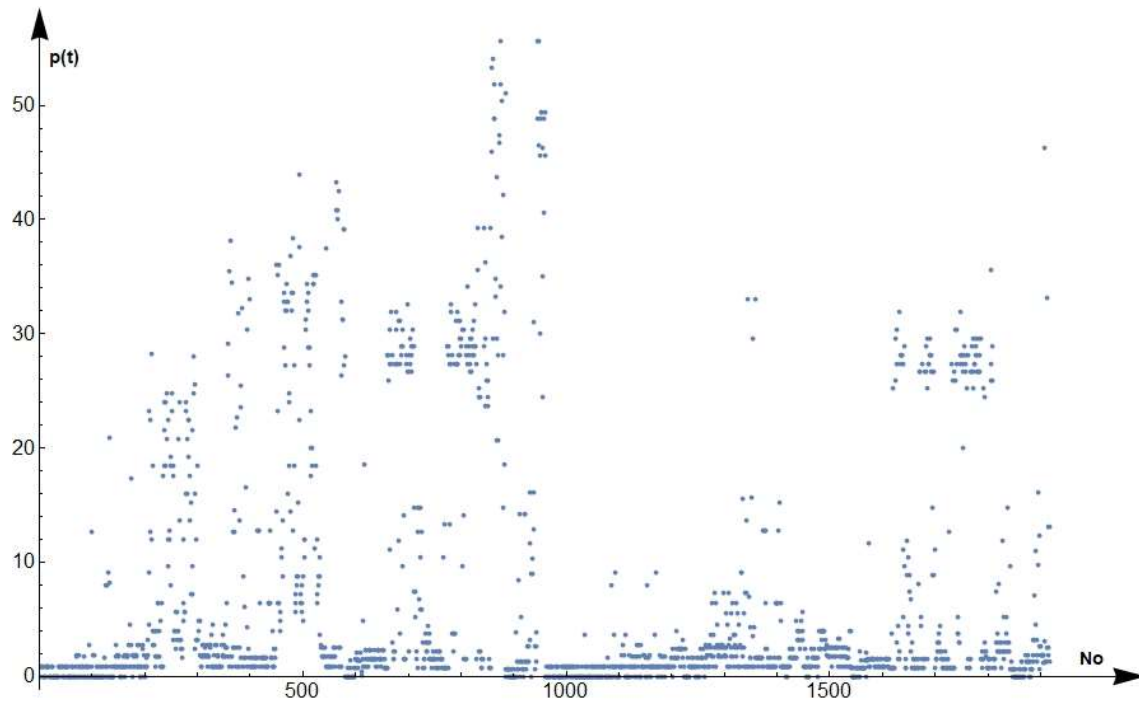
Figure 2 shows 1918 elements of the empirical database. The ordinal numbers of the measurements are shown on the x-axis, while the values of the wear percentage of the LG section are shown on the y-axis. Each element of the input database is associated with one point on the graph shown in Figure 2. This empirical database was used in the statistical analysis that was conducted to establish a linear relationship between the wear percentage of metal structures and the operating time of the ships. The statistical analysis enables the prediction of the time in the operation cycle when LG structures reach the critical values of the corrosive wear percentage.

Figure 2. Input corrosion depth database for the LG structural elements.

This paper analyzed the total of 1918 empirical data points on the depth of corrosion that was collected during 20 years of ship operation. Corrosion depths were calculated as wear percentage based on the original metal plate thickness. The original plate thickness values were first grouped into three sets based on thicknesses intervals (11–13 mm, 13–15 mm, and 15–18 mm), whereby all numerical values were expressed in mm. The values of the wear percentage of the LG metal structures were calculated based on the average thickness of metal plates for each interval and the collected empirical data. Basic descriptive statistics were calculated for the obtained wear percentage. Table 4 exhibits the corresponding values of descriptive statistics related to the measured corrosion depth expressed in nm/year. After sorting the data in ascending order, the values below in which 25% and 75% of the data are found were determined. In other words, the first (Q1) and the third quartile (Q3) were determined, respectively.

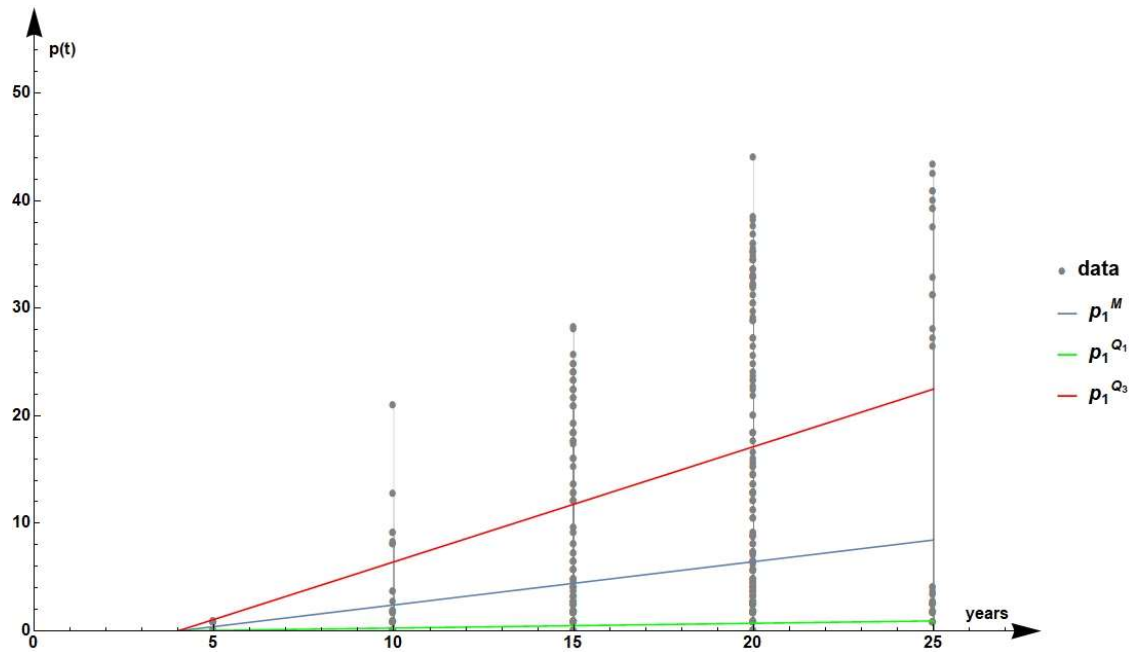
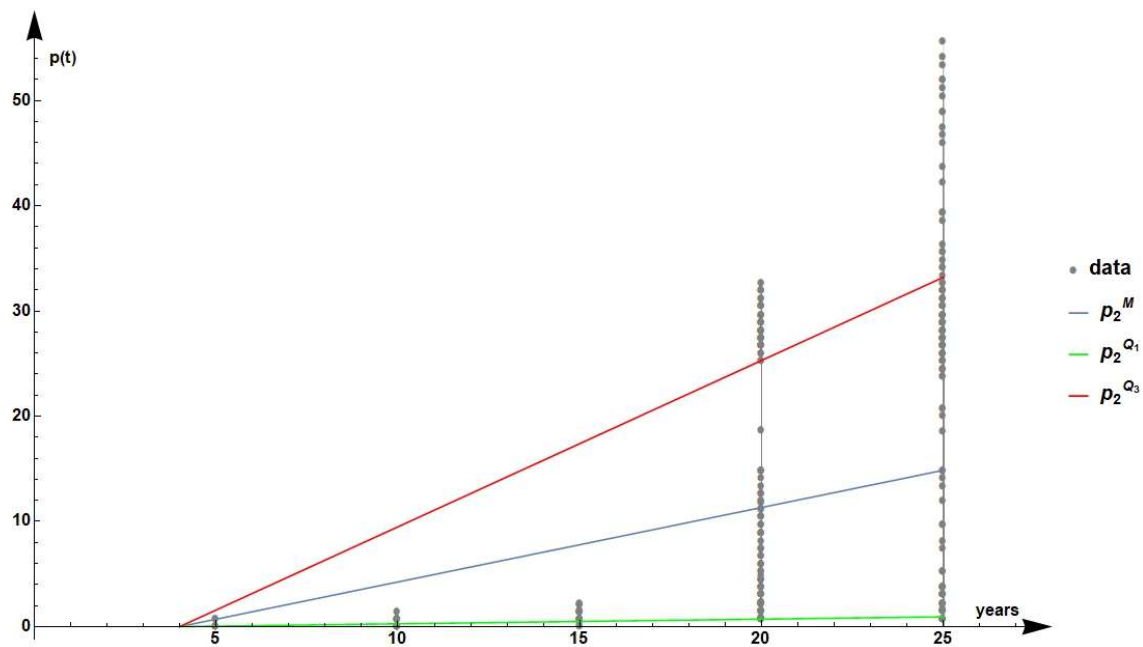
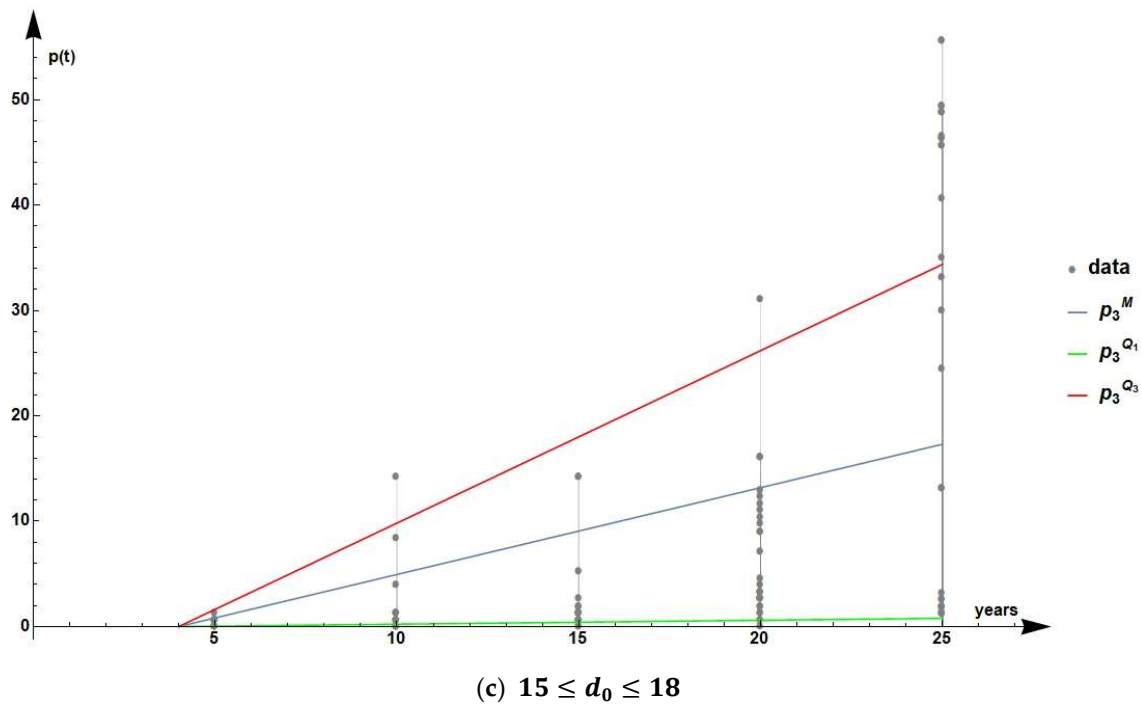
Figure 3 graphically presents the linear dependence of the corrosive wear percentage (Equations (6)–(14)) in the LG section on the elapsed time of ship operation. In addition, these figures show the empirical data on the wear percentage of the LG section that were grouped in terms of the length of ship operation. According to the figures, the lowest percentage of corrosive wear was recorded for the original steel thickness in 13 mm–15 mm intervals on the ships that were in operation for less than 15 years. The ships aged between 20 and 25 years exhibited significantly different characteristics. In the case of the older ships, the highest percentage of corrosive damage was noted at higher original thickness values of the metal plates, while the thinnest metal plates showed stable corrosive behavior without drastic and abrupt changes.

Figure 3. Linear models for the minimum (a), mean (b), and maximum (c) corrosion wear percentage of the LG ship structures.

The points when the LG ship structures reached critical values of corrosive wear percentage, which were defined by classification societies, can be determined based on the linear models formed. The critical value is typically 10% of the wear of the original metal plate thickness. When a certain structure reaches the critical value, the ship has to be withdrawn from use and repaired. The paper examined the maximum values of corrosive wear. Additionally, the detection of the time when wear percentage reaches the critical, predefined values is highly important because ship operation is considered unsafe once critical points are reached. Based on the formed linear corrosion models and the

allowable wear of 10%, the research identified the time when LG structures reached the maximum values of corrosive wear percentage. The analysis also included less critical values of corrosive wear such as 15%, 20%, and 25%.

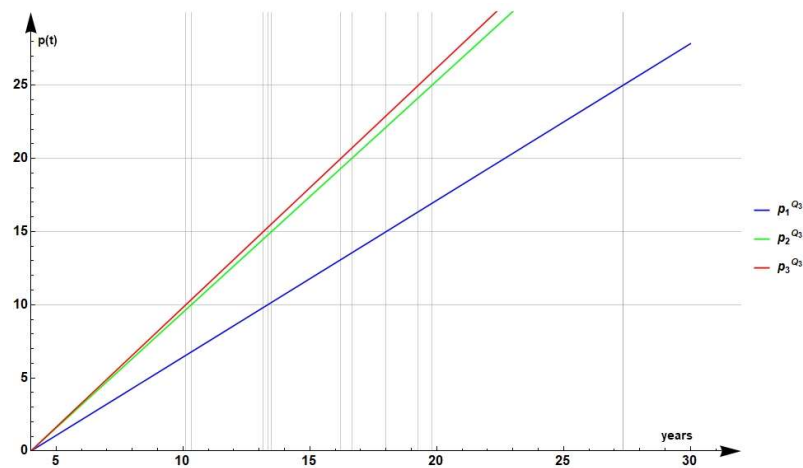
Figure 4 additionally illustrates the critical wear of 10%, 15%, 20%, and 25%, as well as the time when these values were reached by the three observed intervals of the original thickness of metal structures. In the case of the 11 mm–13 mm interval of the original steel thickness, the prescribed wear limit of 10% was reached after 13.3 years. On the other hand, in the case of the maximum thickness (15 mm–18 mm interval), the wear of 10% was reached after 10.1 years of operation.

Figure 4. The critical values of the maximum wear percentage—of LG.

According to Figure 4, corrosive processes on LG are highly intensive. Therefore, considering the total wear of 10% of the longitudinal girder area, the entire area should be replaced after 10 to 13 years of usage. The projected ship lifespan of 25 years is, thus, unreachable. Furthermore, corrosion intensity exceeds the projected corrosion margins, and better optimization and the increase in corrosion margin are necessary for the design phase.

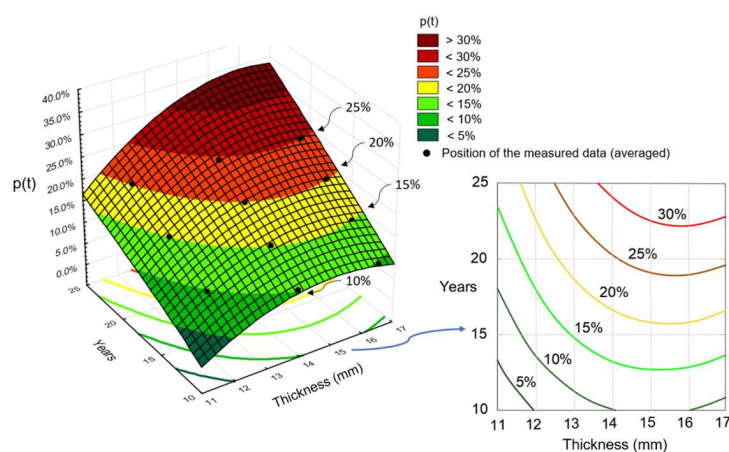
Figure 5 shows the percentage of corrosion depth on LG, which is plotted against the operating time and built-in thickness. The plotted surface is created based on the empirical data on ageing bulk carriers using the cubic spline function. Black spots represent the position of the average values of the measured data that were previously examined (11–13 mm, 13–15 mm, 15–18 mm). Different ranges of the wear percentage of metal plates are highlighted in Figure 5 in different colors, as shown in the corresponding legend. Moreover, the graph shows the position of plating replacement criteria (10%, 15%, 20%, and 25%) that are following the relevant requirements of classification societies. These sections are further projected on the year/thickness plane and illustrated by the figure on the right that depicts the relationship between age and thicknesses of LG.

Figure 5. Corrosion depth percentage plotted against the operating time and built-in thicknesses of the LG of the bulk carriers examined.

The data above show that thicker longitudinal girders reach the replacement criteria faster. For example, an LG whose thickness is 12 mm will reach a 20% of corrosion depth percentage in around 22.5 years. The limit of 25% will not be reached at all and replacement would not be necessary. However, an LG that is 15–16 mm thick will reach the limit of 20%

in about 16 years and the limit of 25% in approximately 19 years. Figure 5 (right 2D plot) shows a range of thickness values (see 14–16 mm) whose corrosion depth is increasing faster than for thin plates since the requirements minima are gravitating towards such a range. These findings correspond to the conclusions from Section 3, which indicate that thinner plates from the same range exhibit a higher margin considering the designed corrosion addition (Figures 1 and 6). Furthermore, the range between 16 mm and 17 mm (Figure 5) offers a glimpse of corrosion depth margin that has an opposite trend in comparison with the margin relevant for the thickness interval between 14 mm and 16 mm.

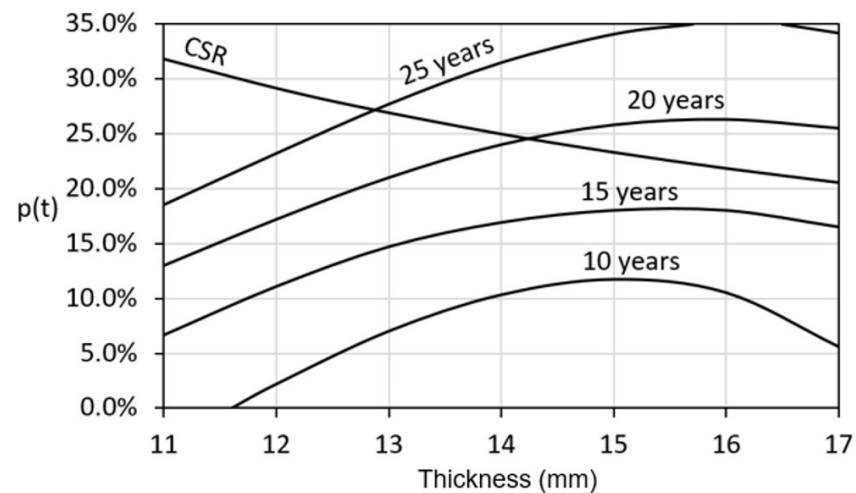
Figure 6. Corrosion depth percentage plotted against the thicknesses of LG: measured data vs. CSR corrosion addition limit.

Additionally, Figure 6 is obtained by the projection of a surface (Figure 5) to the thicknesses/percentage (i.e., vertical) plane based on operating time. Moreover, the CSR data (corrosion addition limit) from Table 2, see IACS [6], overlap with the curves allowing the comparison between measured and designed values.

The CSR corrosion addition and 25-year curve intersect approximately at 12.8 mm and have different trends. Below the limit of 12.8 mm, the CSR corrosion addition is providing a larger margin than 25 years of full operating life. However, for the thickness above 12.8 mm, the designed margin of 3.5 mm (see Section 3) of the LG does not sustain the entire operating cycle.

Therefore, this study proposes an estimation curve for the designed corrosion addition of LG (located between FOT and WBT) and emphasizes the dependence on the thickness of plating (Figure 6, 25-year curve) that varies between 11 mm and 17 mm for the LG. The CSR curve for the thickness below 12.8 mm and the 25-year curve for the thickness above 12.8 mm could be used for more precise estimation. In that way, corrosion addition would not depend only on the original thickness of structural elements. Moreover, corrosion addition would be expressed as a depth percentage of the original thickness, rather than an absolute value.
