Goran Vizentin

**DURABILITY MODELING AND ANALYSIS
OF COMPOSITE STRUCTURES EXPOSED
TO THE MARINE ENVIRONMENT**

DOCTORAL DISSERTATION

Rijeka, 2022.

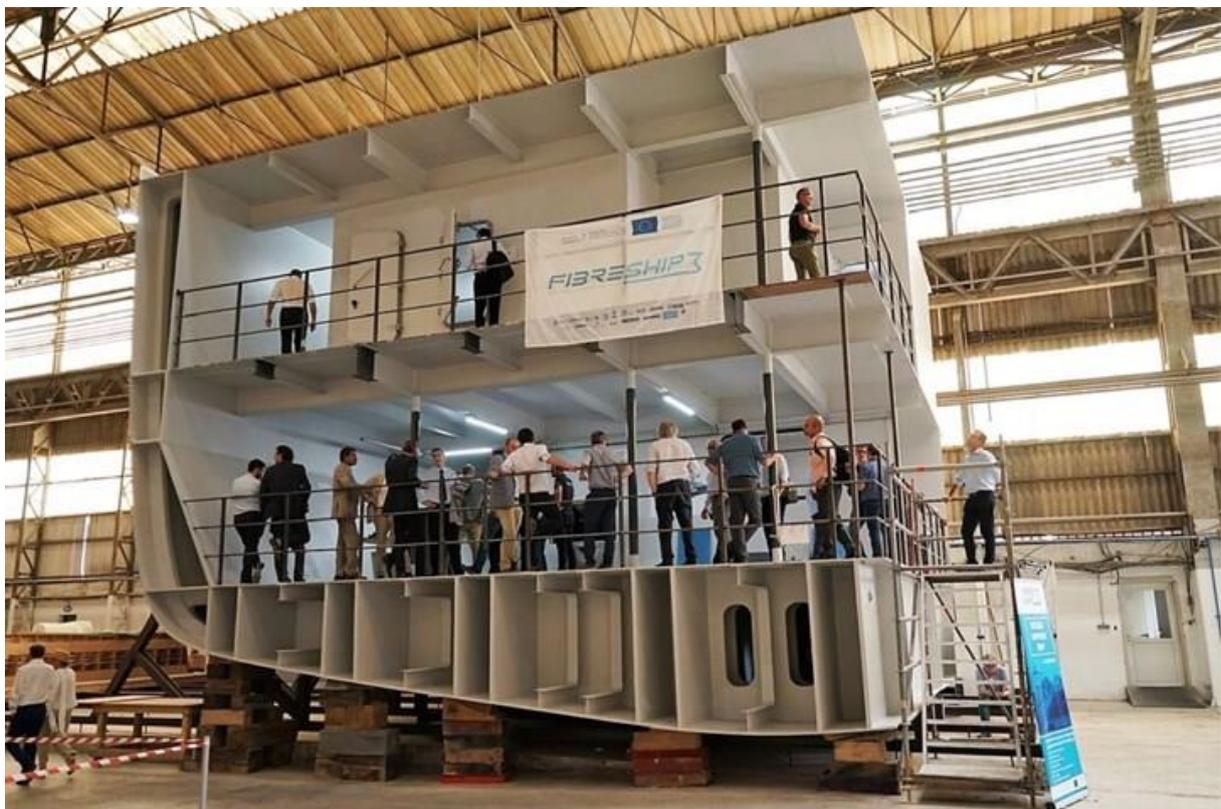
Figure I.1 Composite ship hull section (source: <http://www.fibreship.eu/fibreship-2nd-public-workshop/>)

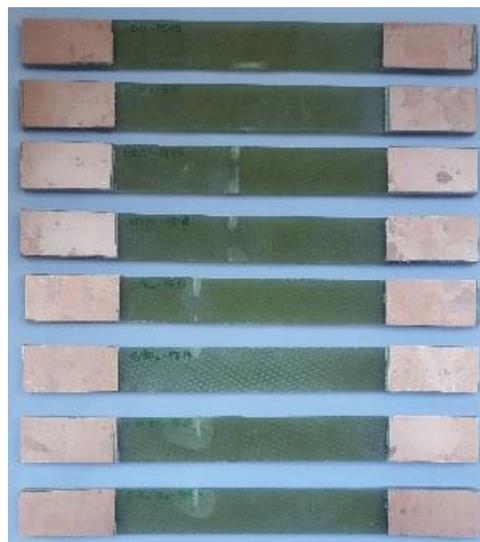
Vacuum assisted infusion process was used for the epoxy/glass coupons and hand layup process was used for the polyester/glass coupons. Reinforcement tabs, made of printed circuit board cutouts and glued at coupon ends prior the tensile test minimized the influence of the tensile test machine's grips pressure on the test results (Belingardi et al., 2011). The size of the tabs was chosen based on ISO 527-4 recommendations.

Figure I.4 Coupons with tabs before submersion

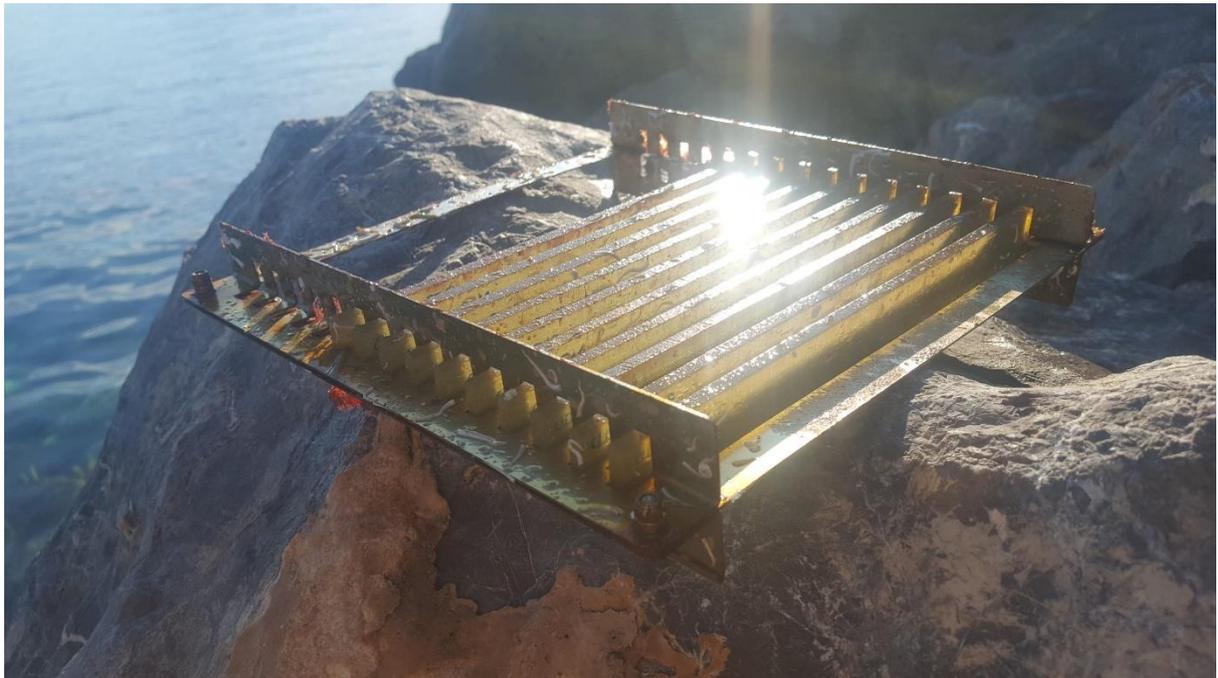
After each of the indicated time periods the coupons were taken out of the sea for analysis of changes in morphological and mechanical properties. The experimental analysis was comprised of optical observations of the coupons’ geometry and surface changes, mass measurements of dry and submerged coupons, optical and scanning electron microscopy and tensile testing.

Figure I.6 Coupons in frame after 6 months of submersion

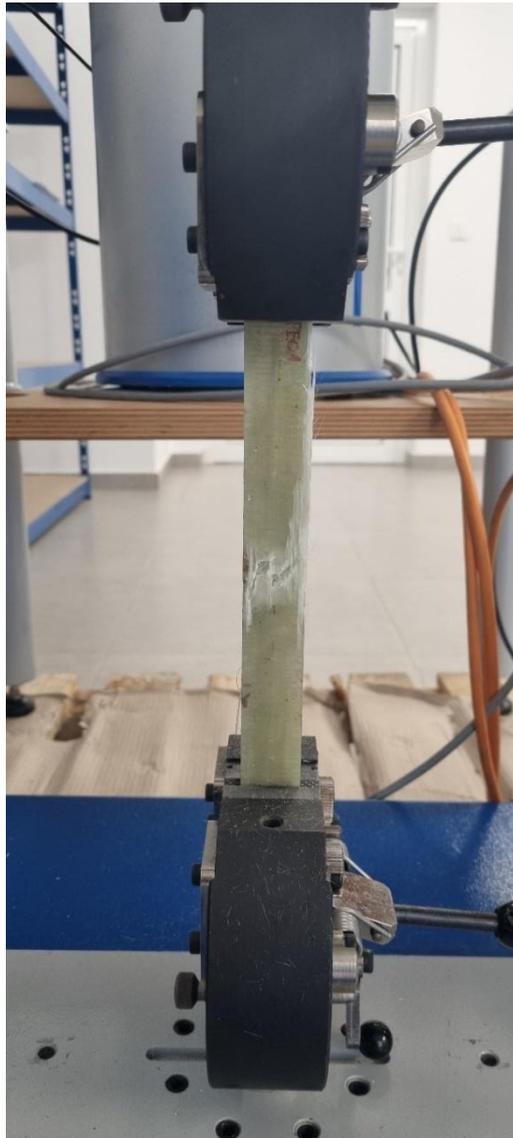
Tensile tests performed on all coupons on the same testing machine (Zwick 400 kN universal testing machine coupled with a BTS Exmacro-H02 macro extensometer, Figure I.7) are instrumental for determining changes in ultimate tensile strength (UTS) for the coupons exposed to the marine environment compared to the reference values for the dry coupons.

Figure I.7 Coupon on completion of the tensile test

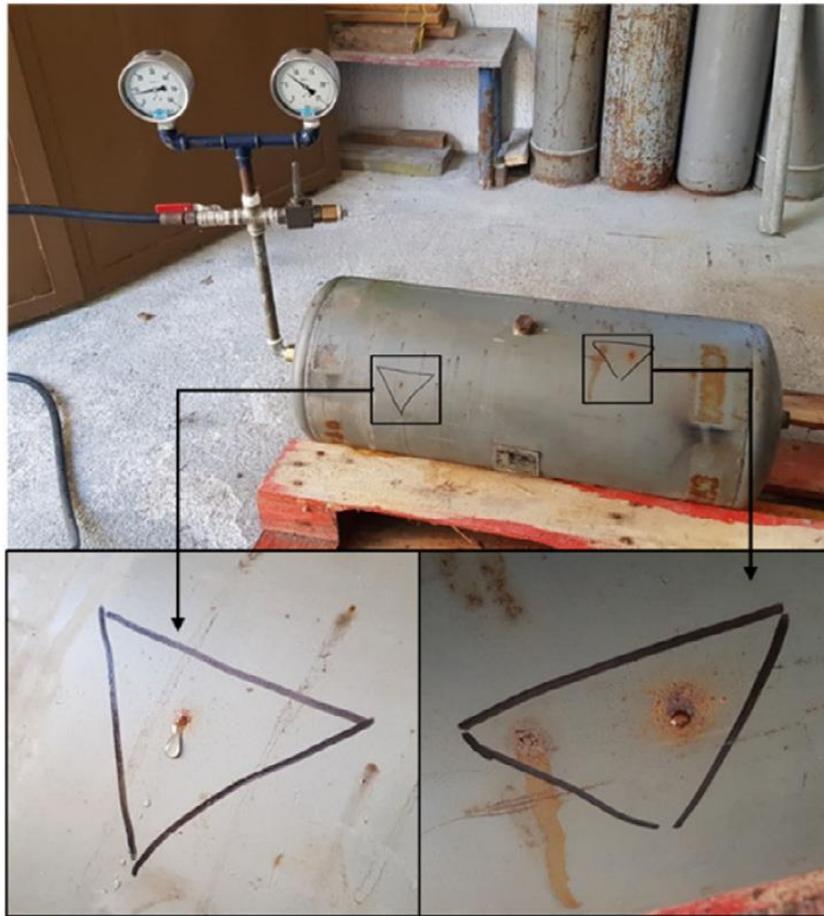
display connected to digital pressure transducer. Hydrostatic pressure test was terminated at that point and experimental failure analysis followed.

Fig. 2. Hydrostatic test setup with details of fluid leakage.

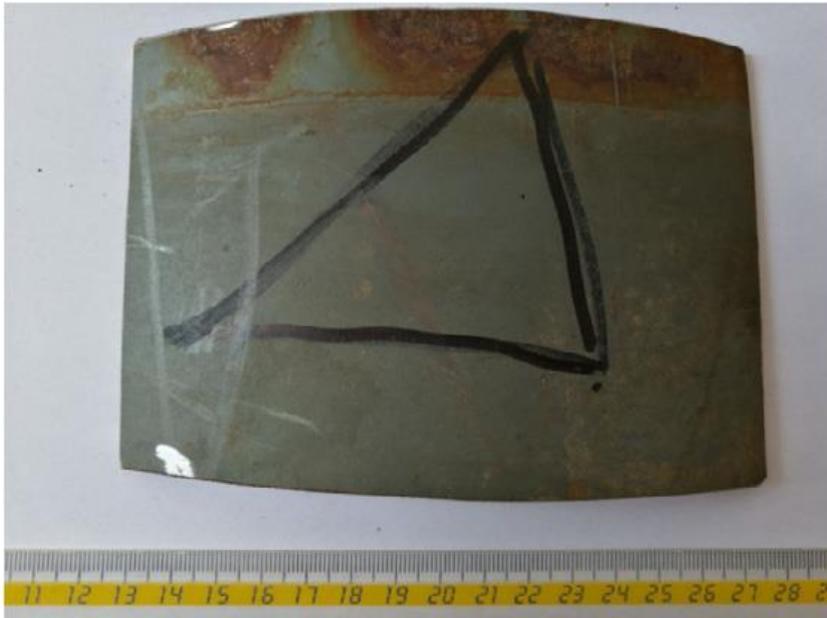
Cut-out specimens containing cracks were used to perform microscopic examination, Fig. 4, using optical and scanning electron microscope (SEM), Figs. 5 and 6.

Fig. 4. Cut-out specimen containing crack used to perform microscopic examination.

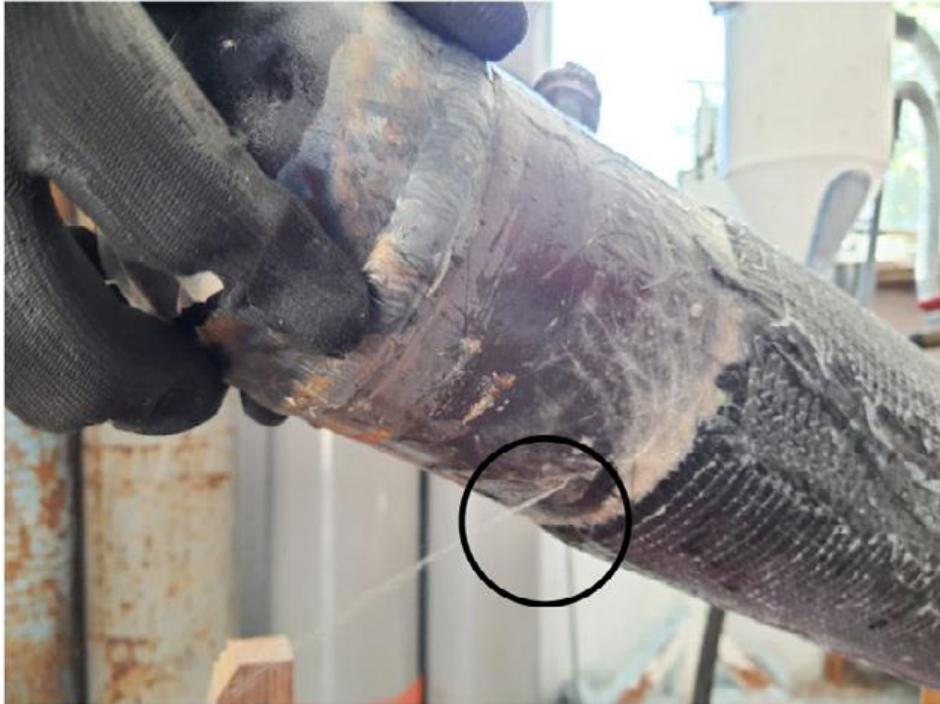
Fig. 21. Detail of the test fluid bursting on the edge of the composite patch.
