Common failures of ship propulsion shafts

Goran Vizentin, Goran Vukelić, Mateo Srok

Review article
Received 16 October 2017
Accepted 13 November 2017

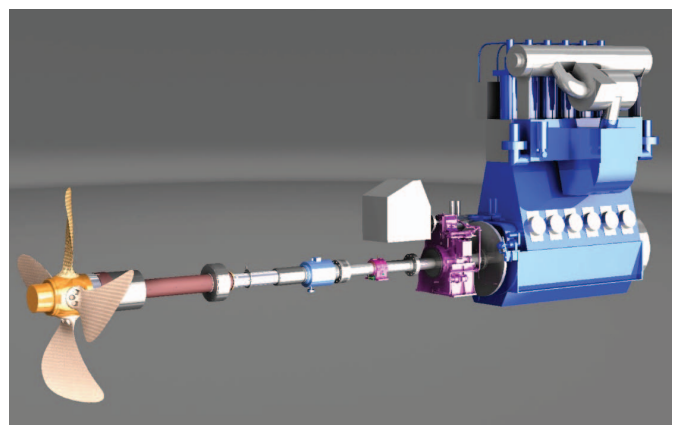
Figure 1 Typical Ship Propulsion System Elements Rendering

The propulsion system has a pivotal role on board ships. A typical marine propulsion system is comprised of the following main parts: main engine, driving device, marine shaft and propeller as shown in Figure 1. As far as fatigue is concerned, the main engine is a complex unit for itself. It represents a vibrations source (impulse operation) for the entire ship and the propulsion system as well. Here, the propulsion shaft will be discussed more in detail.

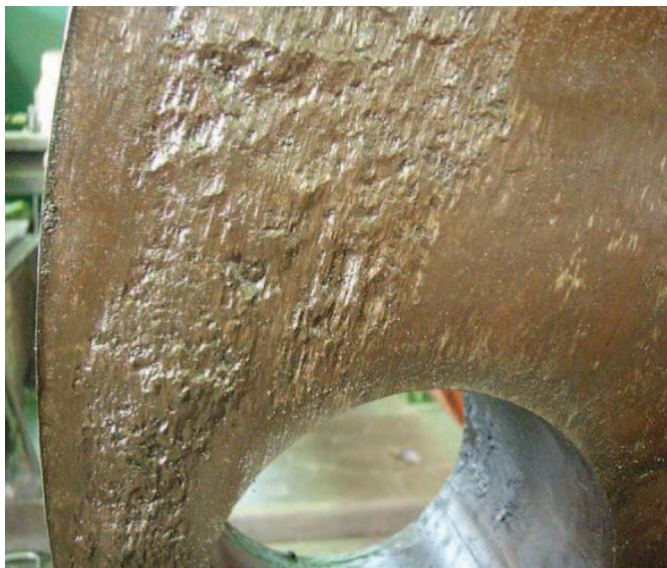
Figure 6 Fatigue Indicative Fretting on Surfaces [13]

of failure growth in planes angled from 35° to 60° which is not characteristic of pure torsion fatigue failures. The analysis has shown that the coupling bolts are subjected to an increasing bending moment which contributes to fatigue crack growth. The experimental research and numerical calculation done in this case study proved the hypothesis of variable bending stress in the coupling as the failure cause.
