# Common failures of ship propulsion shafts

Vizentin, Goran; Vukelić, Goran; Srok, Mateo

Source / Izvornik: **Pomorstvo, 2017, 31, 85 - 90**

**Journal article, Published version**

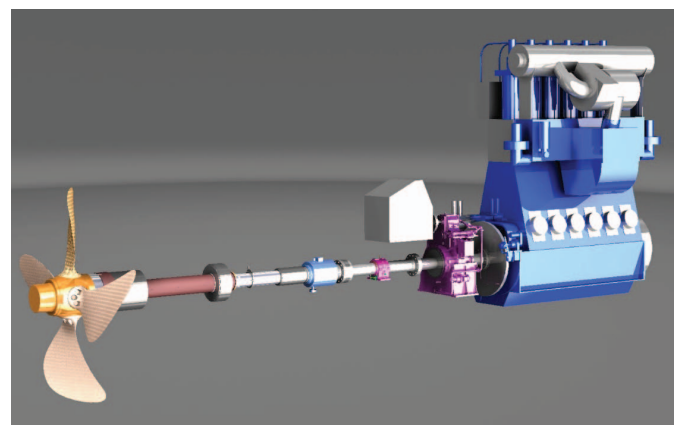
**Figure 1** Typical Ship Propulsion System Elements Rendering

The propulsion system has a pivotal role on board ships. A typical marine propulsion system is comprised of the following main parts: main engine, driving device, marine shaft and propeller as shown in Figure 1. As far as fatigue is concerned, the main engine is a complex unit for itself. It represents a vibrations source (impulse operation) for the entire ship and the propulsion system as well. Here, the propulsion shaft will be discussed more in detail.

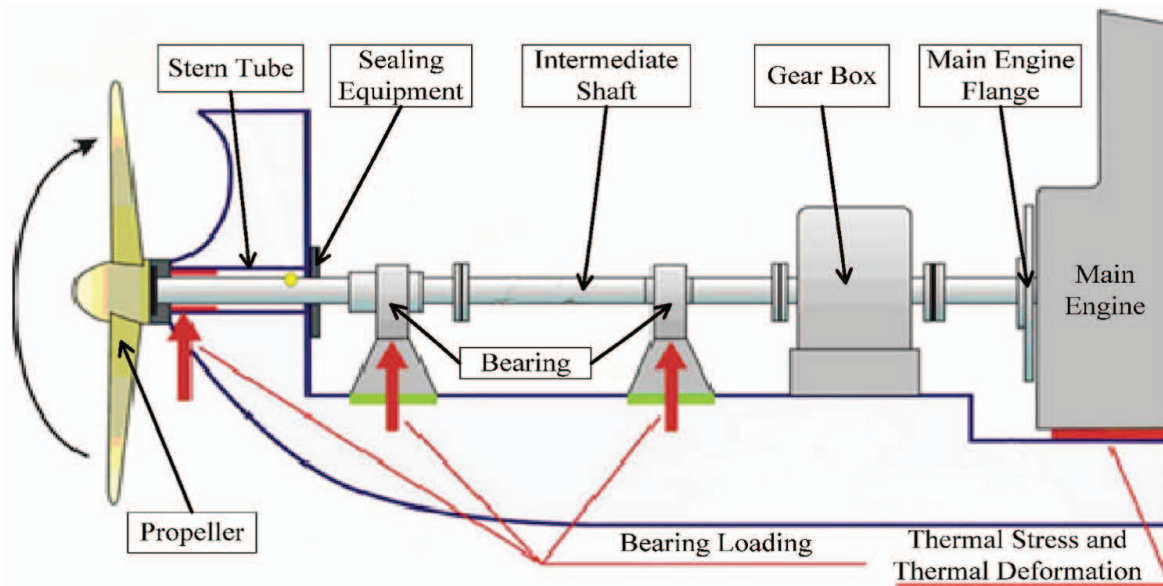
Figure 2 Propulsion System Elements and Loads Schematics [1]

The propulsion shaft is subjected to various types of loading during operation, namely torque moment, bending moment, axial thrust force and transversal loads (gravitational and centrifugal forces). The operating environment of the propulsion system is characterized by significant changes in temperatures and humidity, aggressive atmosphere (salt and/or oil mist), long lasting interrupted operating time (several months) and variations in load amplitudes. The risk of failures of the propulsion system additionally increases with the severity of sea and weather conditions as they have a direct effect on the dynamics of the load variation. All of the above has a direct influence on fatigue behaviour and life time of the propulsion shaft.

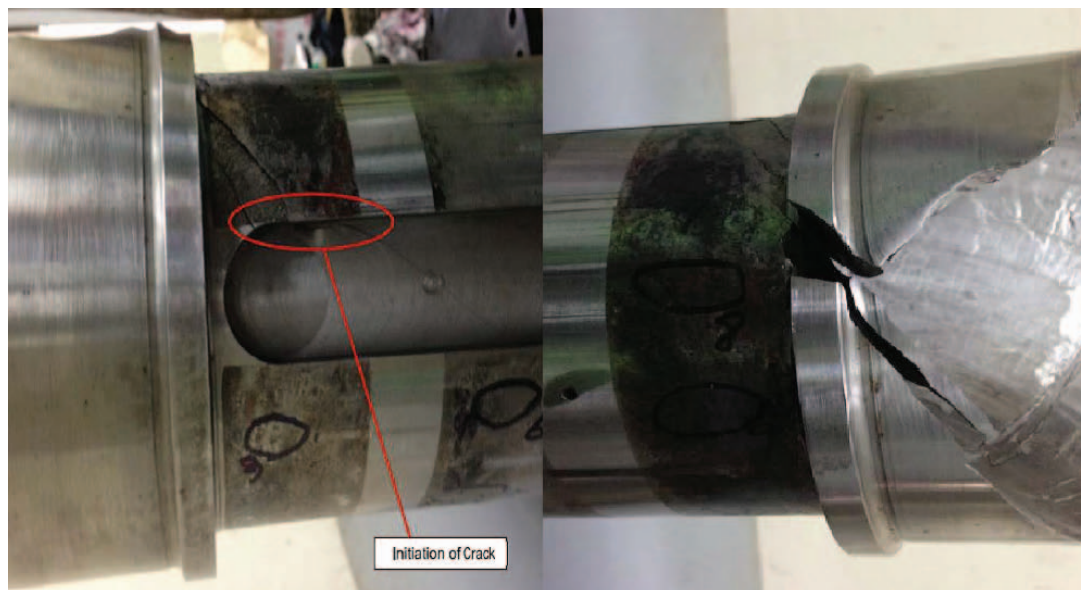
Figure 3 The Characteristic Torsional Failure Crack Shape [8]

The geometry of the ends of keyways represents a stress concentration factor in the cases of torque transmission through shaft keys for dynamic vibrational loads. Faulty machining of shaft key elements (key groove, keyway and key) geometry, inadequate run out radii or material imperfection can be root causes of torsional fatigue failure in shaft keys. The characteristic torsional failure indicator is the crack pattern that initiates at the end of the keyway and propagates in a 45° rotational direction in a helical shape, shown in Figure 3.

Various case studies [8, 9] have shown that inadequate torsional vibration calculation parameters (shaft elements stiffness and damping, natural frequencies, safety factors) and a subsequent poor design of the shaft's keyway cause failures. In this case a root cause analysis has been made by the analytical stress calculation process MIL G 17859D and VDI 3822 standards. A FEM model has been used in order to verify the existing fracture characteristics and causes.

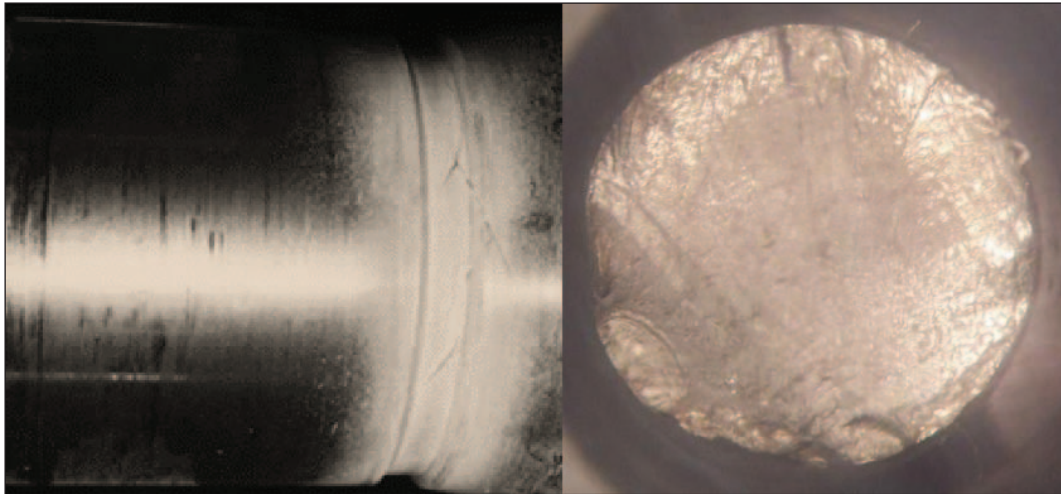
Figure 4 Shaft Fillet Failure Crack Shape [10]

Fillets, tapers and chamfers in the shaft geometry also represent geometrical stress concentrations. Inadequate design of these elements can lead to fatigue failure. Case

studies of fractures initiated at this elements [10], [11] show fatigue due to cyclic torsional-bending load, with a crack that originates in multiple points on fillet shoulders on the shaft, gradually reducing the load bearing area of the shaft as it grows, and finally resulting in a sudden failure during overload as shown in Figure 4. The analysis for this case study has been comprised of chemical composition analysis, micro-structural characterization, fractography, hardness measurements, and finite element simulation.

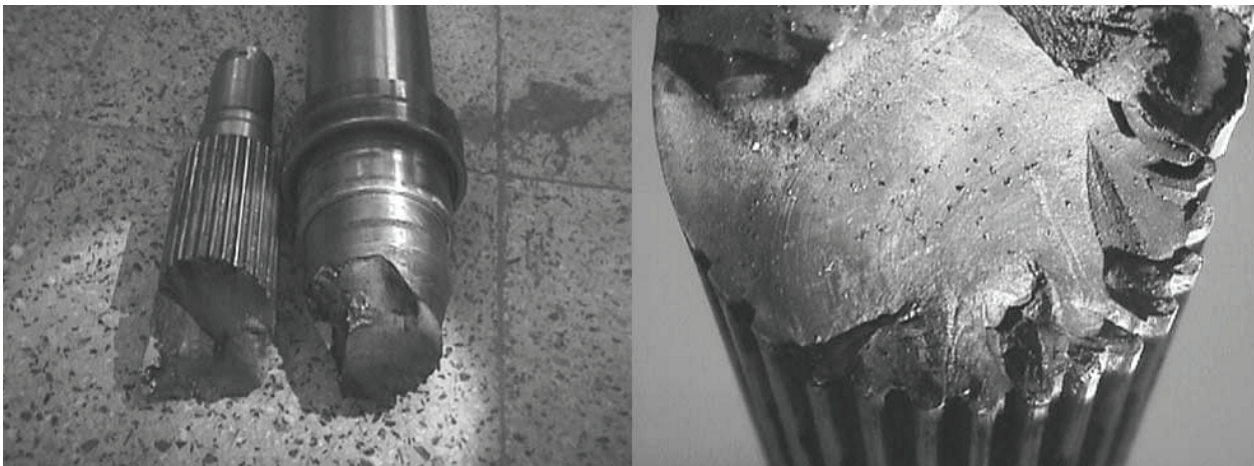
Figure 5 The Characteristic Torsion Failure Crack Propagation Shape (45° angle) [10]

The alternatives to shaft key joints are spline joints which are press fitted to other shaft elements. The analysis of spline joint failure [12] has shown that the press fitting of the joining elements can cause surface deformation which in turn causes surface cracks formation. Cracks usually start on the spline teeth at the shaft junction zone, Figure 5. Torsion fatigue caused by fluctu-

ating stress promotes crack growth and propagation. Inhomogeneity of the shaft material can additionally assist crack propagation.

In this case, a visual and macroscopic inspection has been performed, followed by material chemical analysis, hardness measurement, optical and scanning electron microscope (SEM) microstructure analysis with X-ray dispersive analysis of particles under the SEM.

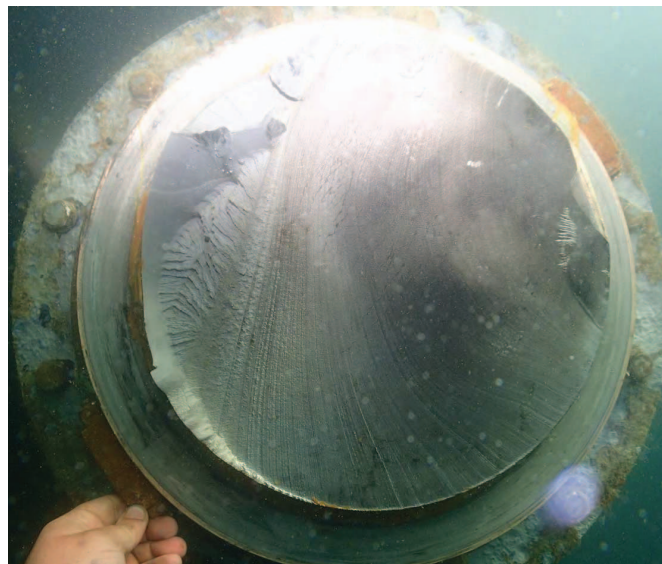
Figure 7 Uniaxial Fatigue Failure Crack Shape [15]

Abnormal performance of the propeller by way of one non-performing malformed blade can generate a uniaxial force which fluctuates once per rotation in a consistent transverse direction across the shaft. The fluctuating force generates a couple which can cause fatigue failure of the propeller hub [15]. Uniaxial type of failure is characterized by a fatigue fracture with a single origination point that progresses across the shaft from the side where the force is being applied and results in the final overload failure occurring on the opposite side from the fluctuating force.

Visual inspection, detail axis alignment measurements, microscopic metallurgical examination, hardness measurements and ultrasonic scanning have been used during the analysis.
