Source / Izvornik: **Journal of marine science and engineering, 2022, 10**

Evaluation of the Corrosion Depth of Double Bottom Longitudinal Girder on Aging Bulk Carriers

Abstract: The longitudinal girder (LG) between fuel oil tanks (FOT) and water ballast tanks in the double bottoms of ships represent critical structural parts whose watertight nature could be harmed by corrosion, thus, causing the pollution of water ballast tanks and adjacent areas. The new common structural rules (CSR) define the minimum thickness values of structural elements and corrosion margins. The assessment of the deviations from the prescribed values during ship operation could optimize the prescribed criteria. Assuming that corrosive processes begin after four years of operation, the paper analyzes a linear model that describes the percentage of plate wear as a function of the built-in thickness of LG of FOT. The research included 20 ships and provided the database for 1918 corrosion depth values. The gauging records included the average values of the original thickness of steel plates grouped in three intervals (11–13 mm, 13–15 mm, 15–18 mm). Based on the difference between the built-in and subsequently

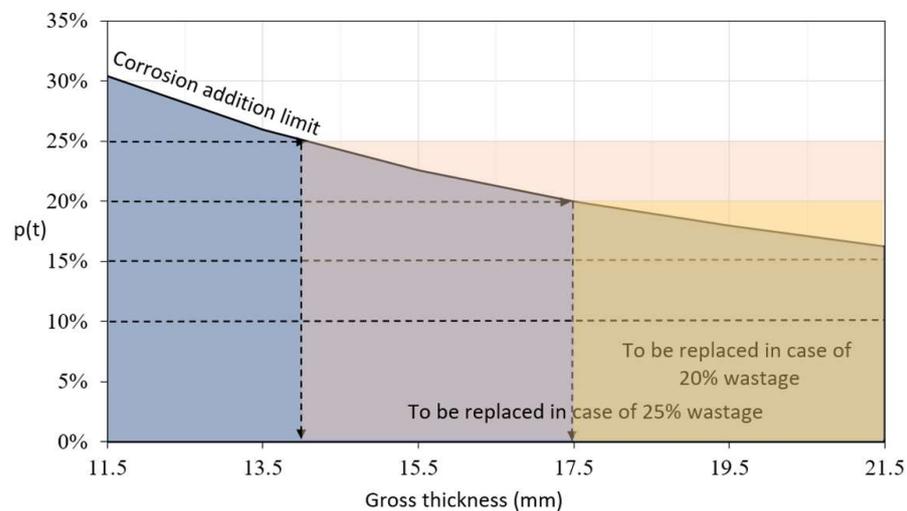
According to Table 2, the design values of corrosion addition and corresponding gross thicknesses are illustrated in Figure 1, considering the most common criteria for plating replacement (shaded areas)—10%, 15%, 20%, and 25% of corrosive wear, labeled here as $p(t)$ and expressed in %. Assuming that the strict criteria of 10% or 15% of corrosive wear are reached, thinner plates would have a larger margin before they reach the corrosion addition limit and net thickness. On the other hand, plating whose thickness is 21.5 mm would have a margin of only 2% (in case of 15% wear).

Figure 1. Gross thickness and corrosion addition percentage plotted against the corrosion wear percentage of gross thickness with corresponding criteria for the LG of bulk carriers.

Considering less strict criteria, such as 25% of wear, all the plates whose thickness exceeds 14 mm of gross thickness would have to be replaced, whereas, in the case of 20% of allowable wear, only the plates that are more than 17.5 mm thick would have to be removed.

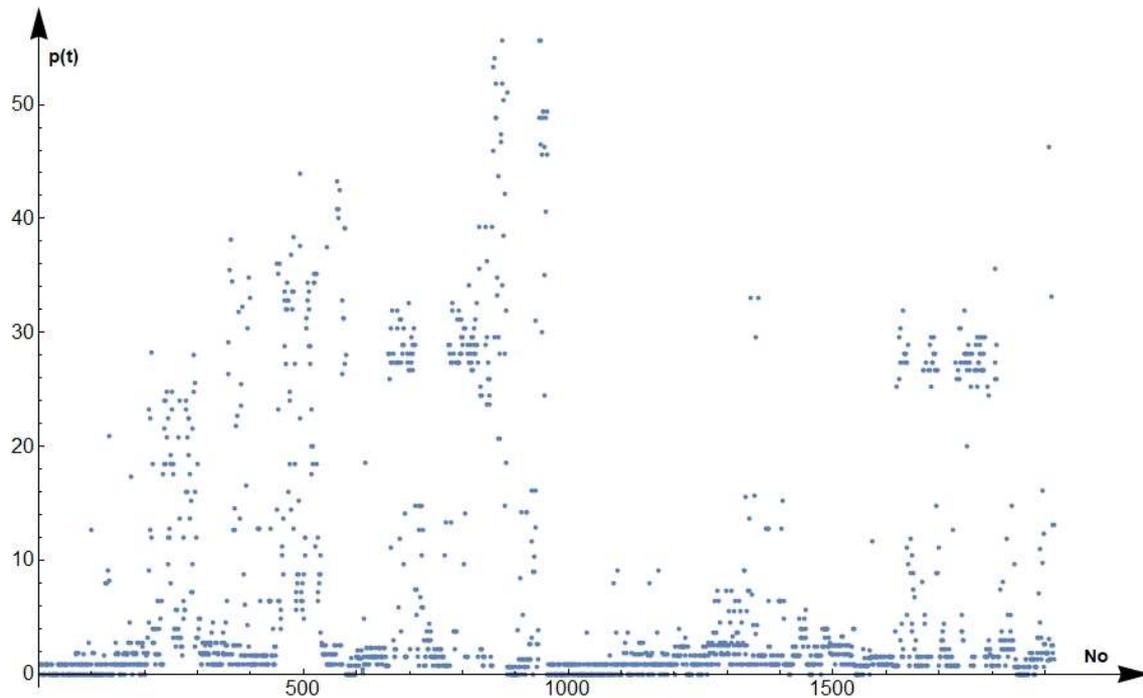
Figure 2 shows 1918 elements of the empirical database. The ordinal numbers of the measurements are shown on the x-axis, while the values of the wear percentage of the LG section are shown on the y-axis. Each element of the input database is associated with one point on the graph shown in Figure 2. This empirical database was used in the statistical analysis that was conducted to establish a linear relationship between the wear percentage of metal structures and the operating time of the ships. The statistical analysis enables the prediction of the time in the operation cycle when LG structures reach the critical values of the corrosive wear percentage.

Figure 2. Input corrosion depth database for the LG structural elements.

This paper analyzed the total of 1918 empirical data points on the depth of corrosion that was collected during 20 years of ship operation. Corrosion depths were calculated as wear percentage based on the original metal plate thickness. The original plate thickness values were first grouped into three sets based on thicknesses intervals (11–13 mm, 13–15 mm, and 15–18 mm), whereby all numerical values were expressed in mm. The values of the wear percentage of the LG metal structures were calculated based on the average thickness of metal plates for each interval and the collected empirical data. Basic descriptive statistics were calculated for the obtained wear percentage. Table 4 exhibits the corresponding values of descriptive statistics related to the measured corrosion depth expressed in nm/year. After sorting the data in ascending order, the values below in which 25% and 75% of the data are found were determined. In other words, the first (Q1) and the third quartile (Q3) were determined, respectively.

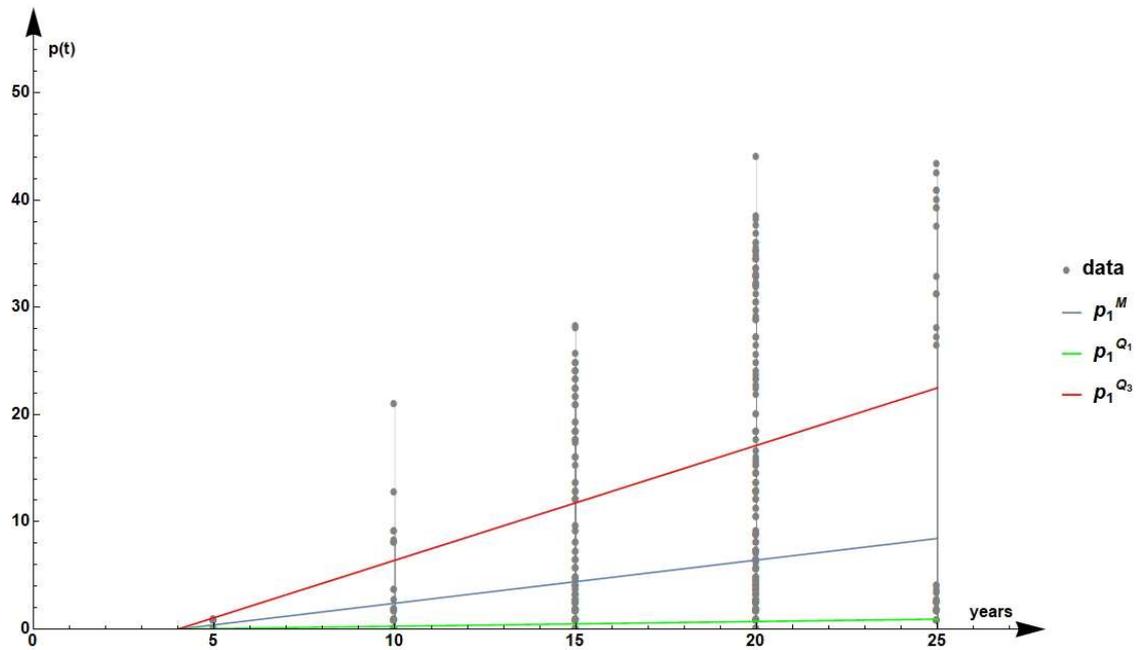
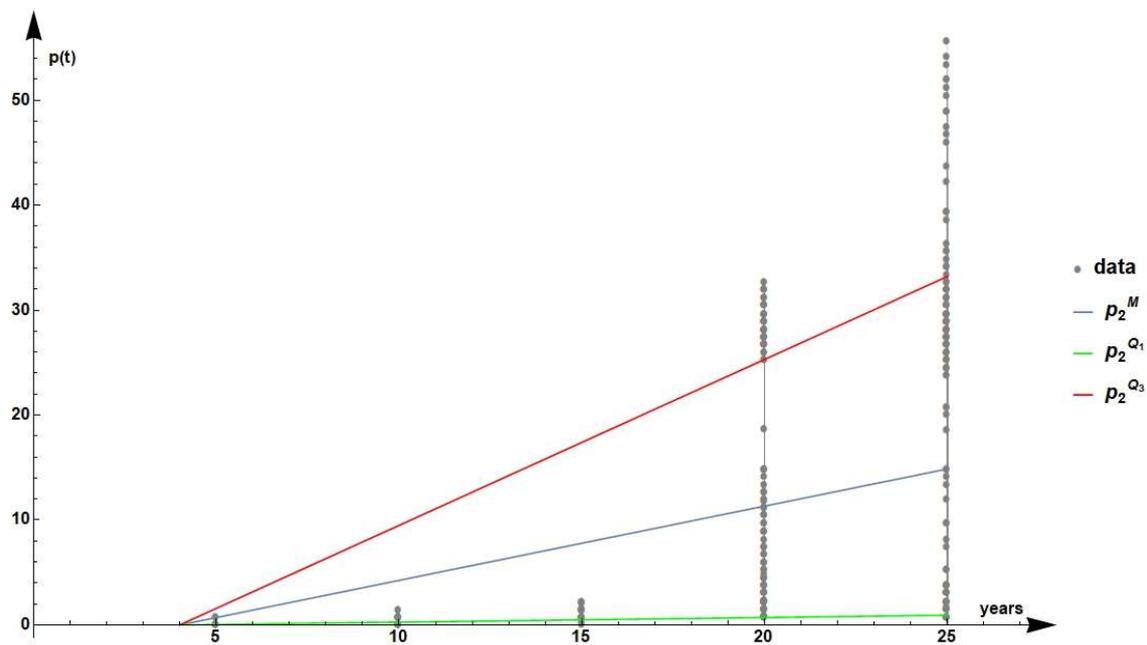
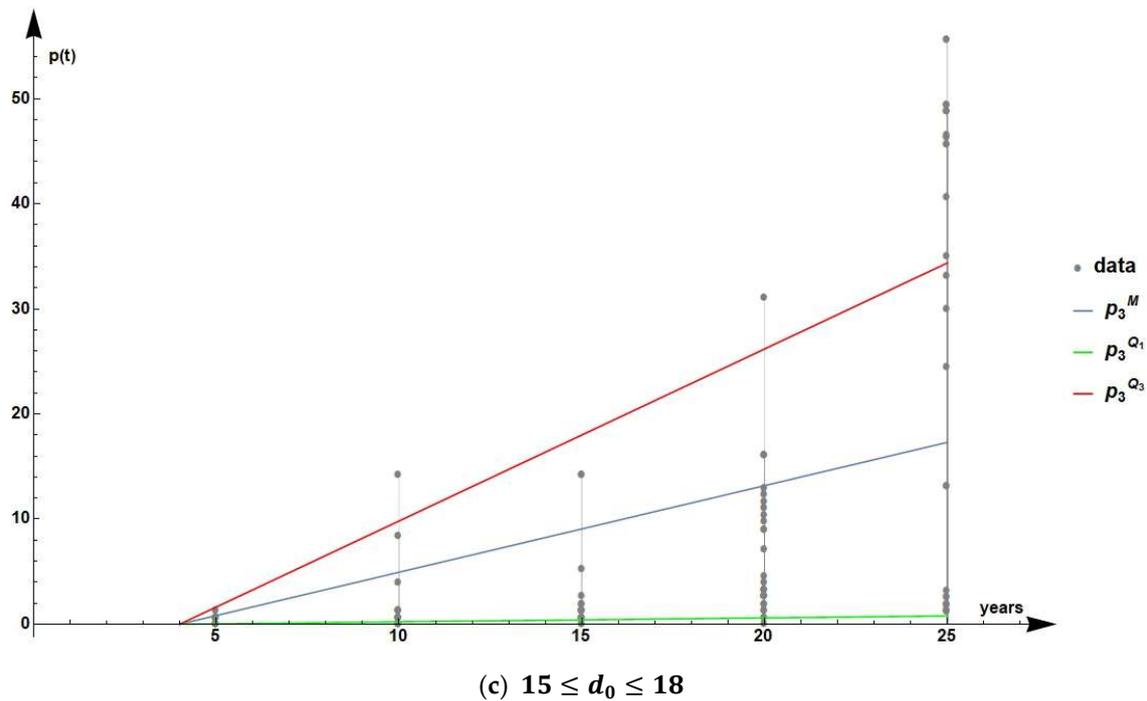
Figure 3 graphically presents the linear dependence of the corrosive wear percentage (Equations (6)–(14)) in the LG section on the elapsed time of ship operation. In addition, these figures show the empirical data on the wear percentage of the LG section that were grouped in terms of the length of ship operation. According to the figures, the lowest percentage of corrosive wear was recorded for the original steel thickness in 13 mm–15 mm intervals on the ships that were in operation for less than 15 years. The ships aged between 20 and 25 years exhibited significantly different characteristics. In the case of the older ships, the highest percentage of corrosive damage was noted at higher original thickness values of the metal plates, while the thinnest metal plates showed stable corrosive behavior without drastic and abrupt changes.

Figure 3. Linear models for the minimum (a), mean (b), and maximum (c) corrosion wear percentage of the LG ship structures.

The points when the LG ship structures reached critical values of corrosive wear percentage, which were defined by classification societies, can be determined based on the linear models formed. The critical value is typically 10% of the wear of the original metal plate thickness. When a certain structure reaches the critical value, the ship has to be withdrawn from use and repaired. The paper examined the maximum values of corrosive wear. Additionally, the detection of the time when wear percentage reaches the critical, predefined values is highly important because ship operation is considered unsafe once critical points are reached. Based on the formed linear corrosion models and the

allowable wear of 10%, the research identified the time when LG structures reached the maximum values of corrosive wear percentage. The analysis also included less critical values of corrosive wear such as 15%, 20%, and 25%.

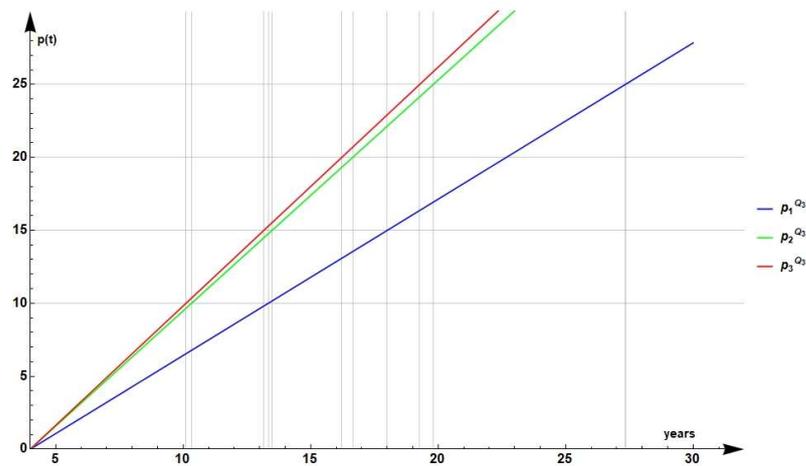
Figure 4 additionally illustrates the critical wear of 10%, 15%, 20%, and 25%, as well as the time when these values were reached by the three observed intervals of the original thickness of metal structures. In the case of the 11 mm–13 mm interval of the original steel thickness, the prescribed wear limit of 10% was reached after 13.3 years. On the other hand, in the case of the maximum thickness (15 mm–18 mm interval), the wear of 10% was reached after 10.1 years of operation.

Figure 4. The critical values of the maximum wear percentage—of LG.

According to Figure 4, corrosive processes on LG are highly intensive. Therefore, considering the total wear of 10% of the longitudinal girder area, the entire area should be replaced after 10 to 13 years of usage. The projected ship lifespan of 25 years is, thus, unreachable. Furthermore, corrosion intensity exceeds the projected corrosion margins, and better optimization and the increase in corrosion margin are necessary for the design phase.

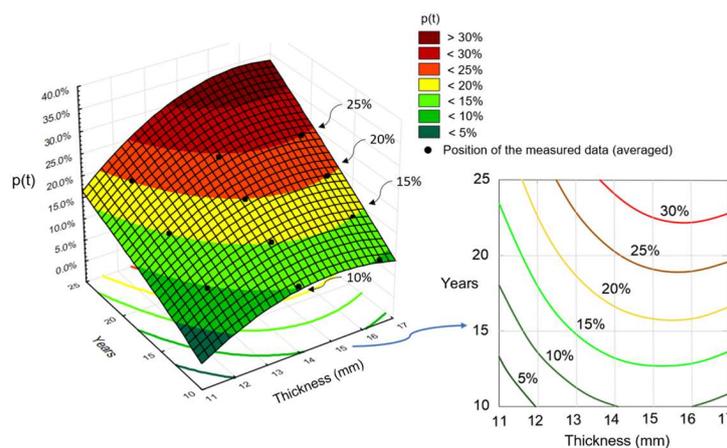
Figure 5 shows the percentage of corrosion depth on LG, which is plotted against the operating time and built-in thickness. The plotted surface is created based on the empirical data on ageing bulk carriers using the cubic spline function. Black spots represent the position of the average values of the measured data that were previously examined (11–13 mm, 13–15 mm, 15–18 mm). Different ranges of the wear percentage of metal plates are highlighted in Figure 5 in different colors, as shown in the corresponding legend. Moreover, the graph shows the position of plating replacement criteria (10%, 15%, 20%, and 25%) that are following the relevant requirements of classification societies. These sections are further projected on the year/thickness plane and illustrated by the figure on the right that depicts the relationship between age and thicknesses of LG.

Figure 5. Corrosion depth percentage plotted against the operating time and built-in thicknesses of the LG of the bulk carriers examined.

The data above show that thicker longitudinal girders reach the replacement criteria faster. For example, an LG whose thickness is 12 mm will reach a 20% of corrosion depth percentage in around 22.5 years. The limit of 25% will not be reached at all and replacement would not be necessary. However, an LG that is 15–16 mm thick will reach the limit of 20%

in about 16 years and the limit of 25% in approximately 19 years. Figure 5 (right 2D plot) shows a range of thickness values (see 14–16 mm) whose corrosion depth is increasing faster than for thin plates since the requirements minima are gravitating towards such a range. These findings correspond to the conclusions from Section 3, which indicate that thinner plates from the same range exhibit a higher margin considering the designed corrosion addition (Figures 1 and 6). Furthermore, the range between 16 mm and 17 mm (Figure 5) offers a glimpse of corrosion depth margin that has an opposite trend in comparison with the margin relevant for the thickness interval between 14 mm and 16 mm.

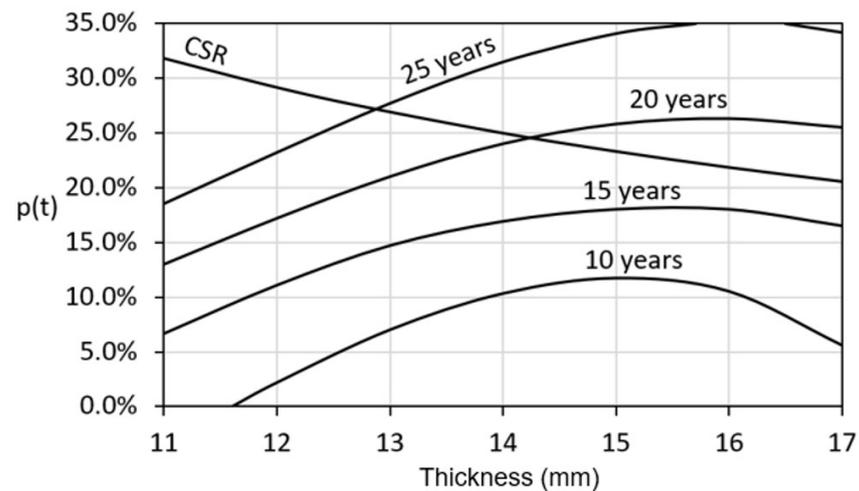
Figure 6. Corrosion depth percentage plotted against the thicknesses of LG: measured data vs. CSR corrosion addition limit.

Additionally, Figure 6 is obtained by the projection of a surface (Figure 5) to the thicknesses/percentage (i.e., vertical) plane based on operating time. Moreover, the CSR data (corrosion addition limit) from Table 2, see IACS [6], overlap with the curves allowing the comparison between measured and designed values.

The CSR corrosion addition and 25-year curve intersect approximately at 12.8 mm and have different trends. Below the limit of 12.8 mm, the CSR corrosion addition is providing a larger margin than 25 years of full operating life. However, for the thickness above 12.8 mm, the designed margin of 3.5 mm (see Section 3) of the LG does not sustain the entire operating cycle.

Therefore, this study proposes an estimation curve for the designed corrosion addition of LG (located between FOT and WBT) and emphasizes the dependence on the thickness of plating (Figure 6, 25-year curve) that varies between 11 mm and 17 mm for the LG. The CSR curve for the thickness below 12.8 mm and the 25-year curve for the thickness above 12.8 mm could be used for more precise estimation. In that way, corrosion addition would not depend only on the original thickness of structural elements. Moreover, corrosion addition would be expressed as a depth percentage of the original thickness, rather than an absolute value.
