Goran Vizentin

**DURABILITY MODELING AND ANALYSIS  
OF COMPOSITE STRUCTURES EXPOSED  
TO THE MARINE ENVIRONMENT**

DOCTORAL DISSERTATION

Rijeka, 2022.

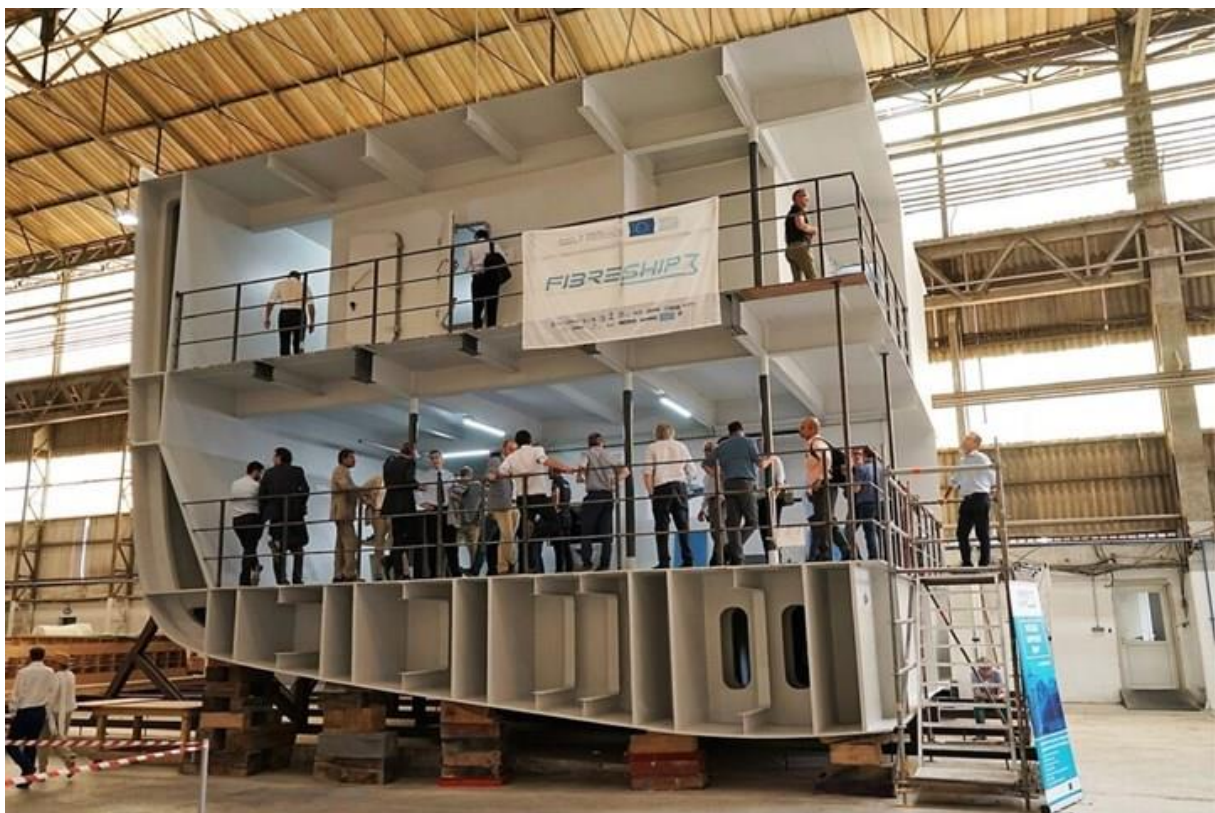
Figure I.1 Composite ship hull section (source: <http://www.fibreship.eu/fibreship-2nd-public-workshop/>)

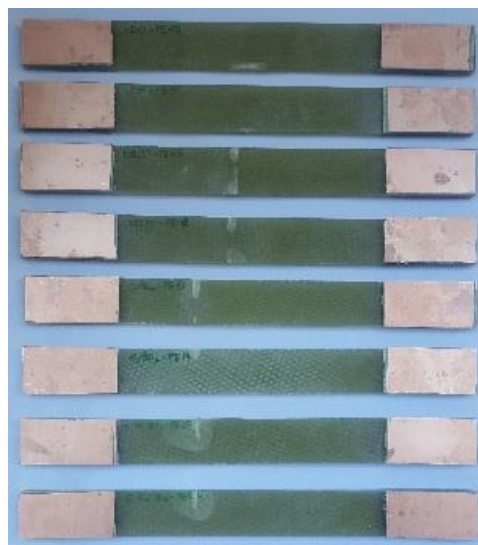
Vacuum assisted infusion process was used for the epoxy/glass coupons and hand layup process was used for the polyester/glass coupons. Reinforcement tabs, made of printed circuit board cutouts and glued at coupon ends prior the tensile test minimized the influence of the tensile test machine's grips pressure on the test results (Belingardi et al., 2011). The size of the tabs was chosen based on ISO 527-4 recommendations.

Figure I.4 Coupons with tabs before submersion

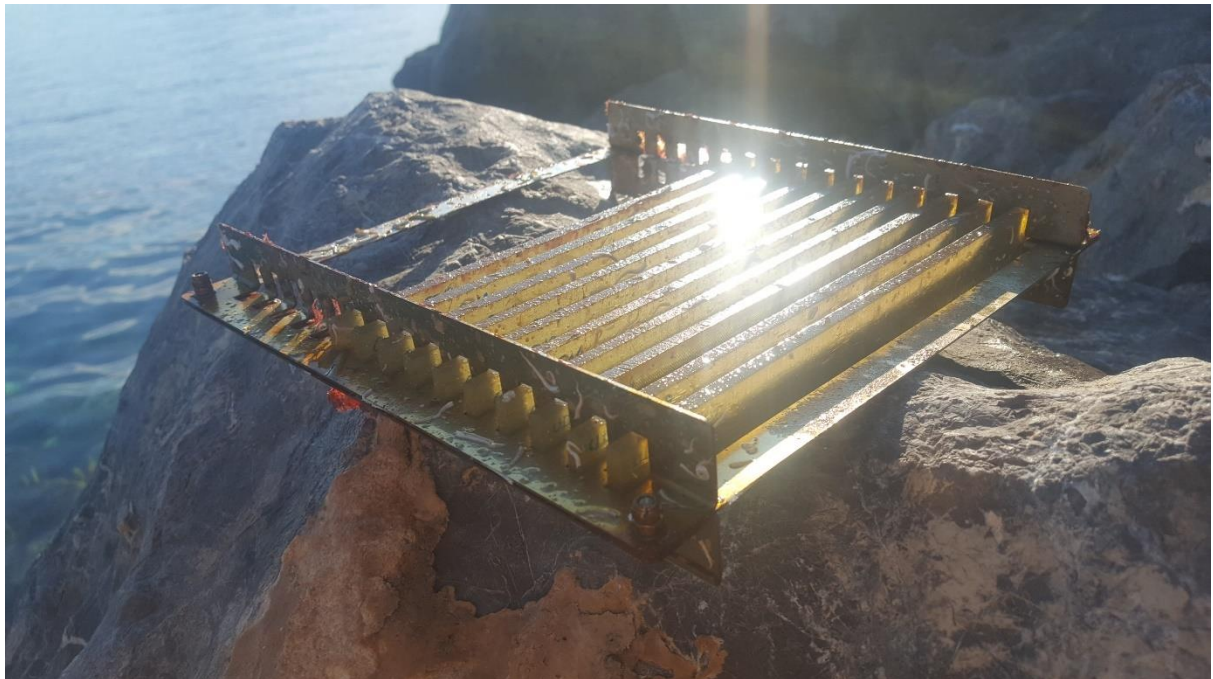
After each of the indicated time periods the coupons were taken out of the sea for analysis of changes in morphological and mechanical properties. The experimental analysis was comprised of optical observations of the coupons’ geometry and surface changes, mass measurements of dry and submerged coupons, optical and scanning electron microscopy and tensile testing.

Figure I.6 Coupons in frame after 6 months of submersion

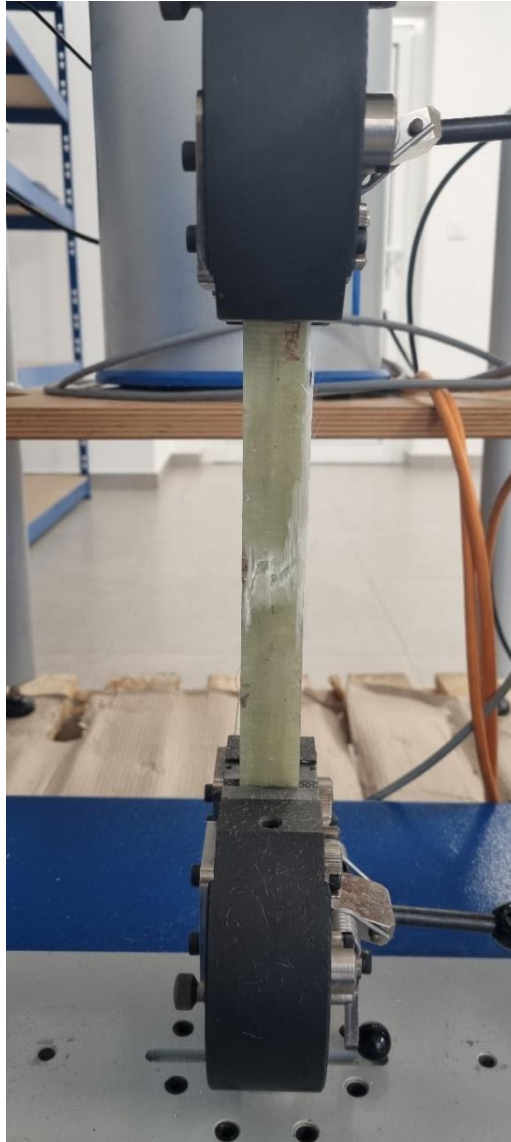
Tensile tests performed on all coupons on the same testing machine (Zwick 400 kN universal testing machine coupled with a BTS Exmacro-H02 macro extensometer, Figure I.7) are instrumental for determining changes in ultimate tensile strength (UTS) for the coupons exposed to the marine environment compared to the reference values for the dry coupons.

Figure I.7 Coupon on completion of the tensile test

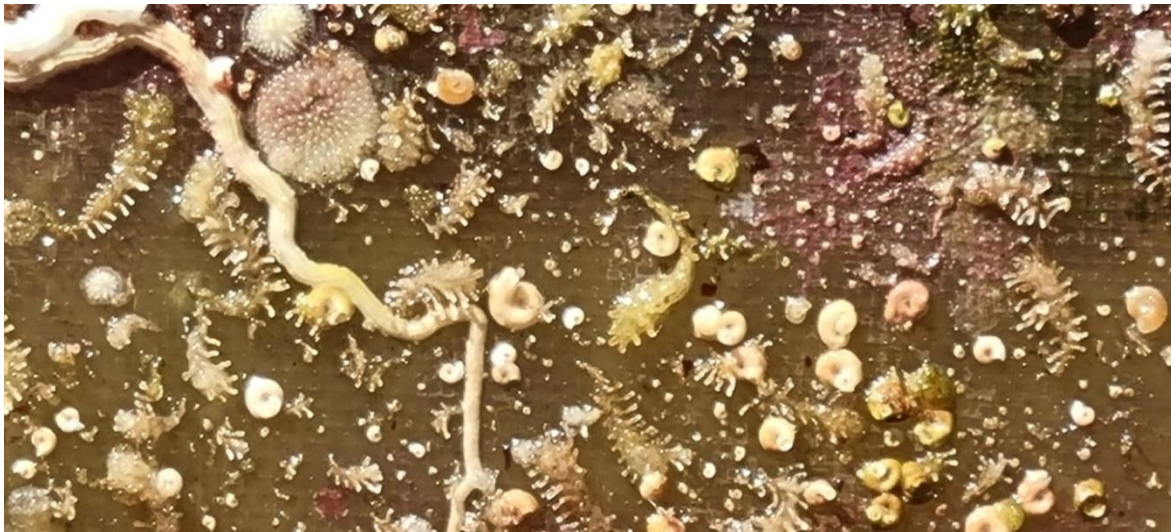
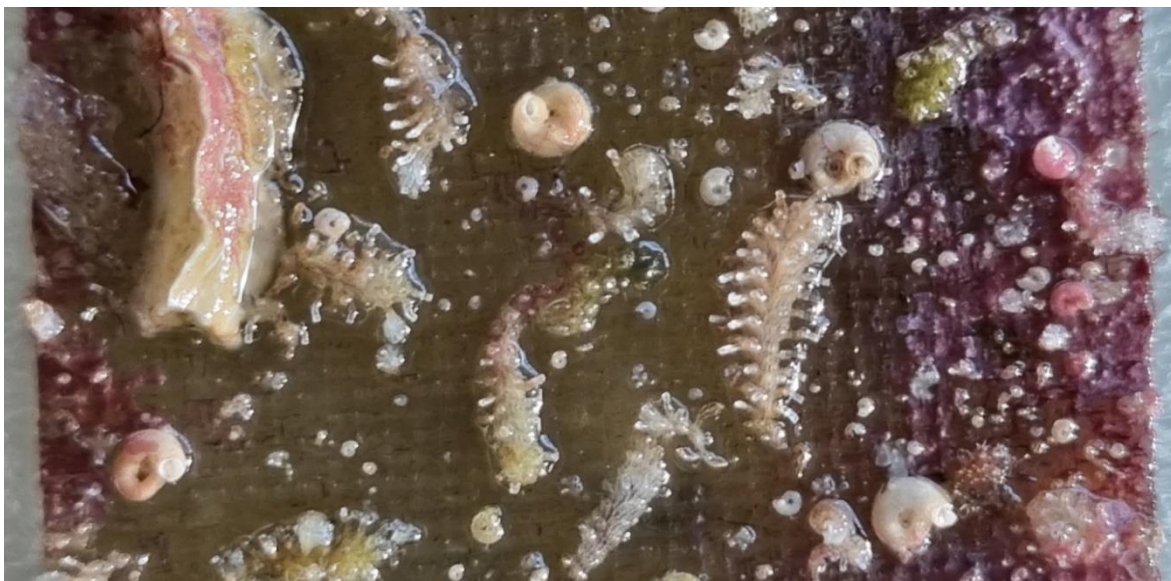
**Fig. 3.** Attached bio-growth after 24 months: a) entire coupon, b) detail optical zoom 3×; c) detail optical zoom 10×

Exemplary images of attached bio organisms after 24 months of submersion are shown in Figure 3.

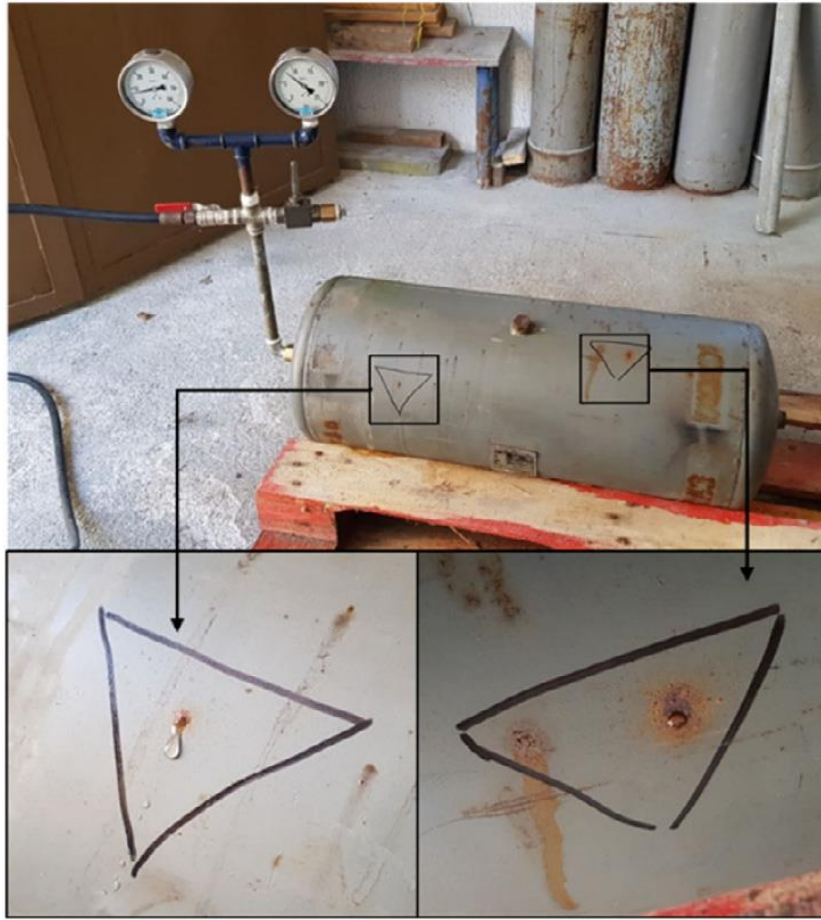
display connected to digital pressure transducer. Hydrostatic pressure test was terminated at that point and experimental failure analysis followed.

Fig. 2. Hydrostatic test setup with details of fluid leakage.

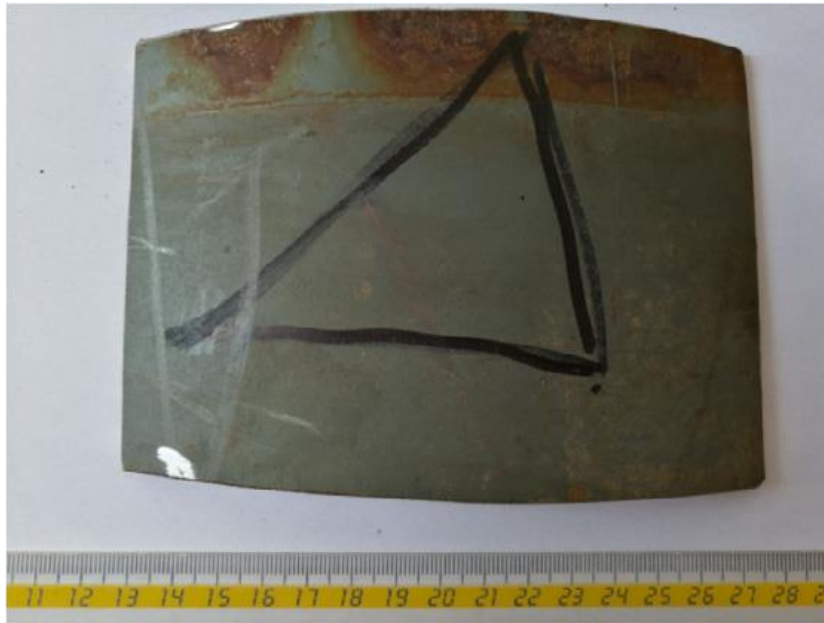
Fig. 4. Cut-out specimen containing crack used to perform microscopic examination.

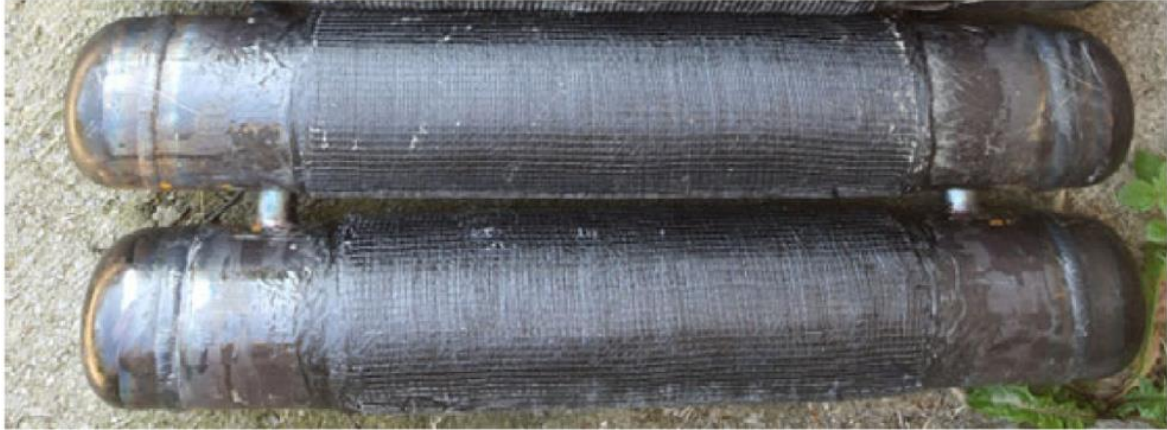
Fig. 19. Pressure vessels with composite patch repair examined using hydrostatic test.

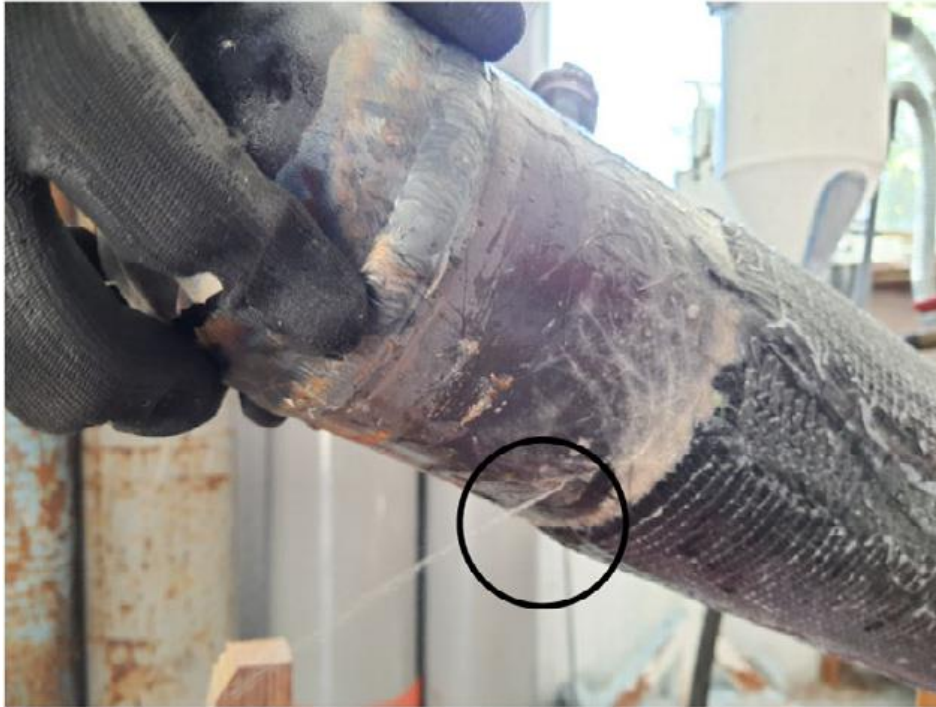
Fig. 21. Detail of the test fluid bursting on the edge of the composite patch.
